**ARCHITECTURAL STUDIES OF THE THREE GRAVE MONUMENTS
IN THE GYMNASIUM COMPLEX AT ANCIENT MESSENE**

Preliminary Report

Juko Ito

**Architectural Mission to Greece
Kumamoto University, Japan**

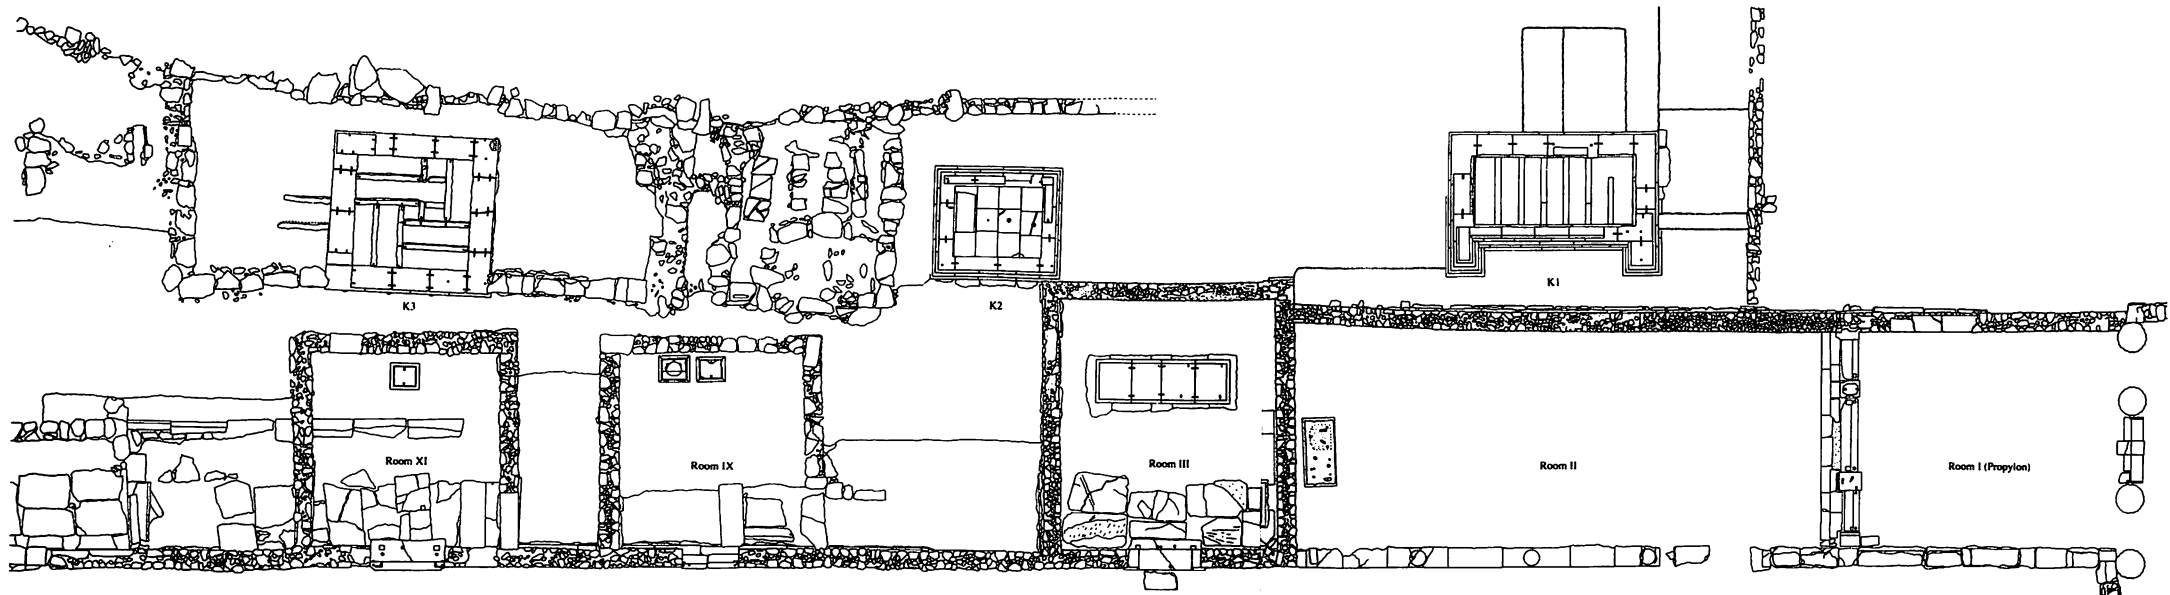
Fig. 1 Environment of the grave monuments, plan and elevation

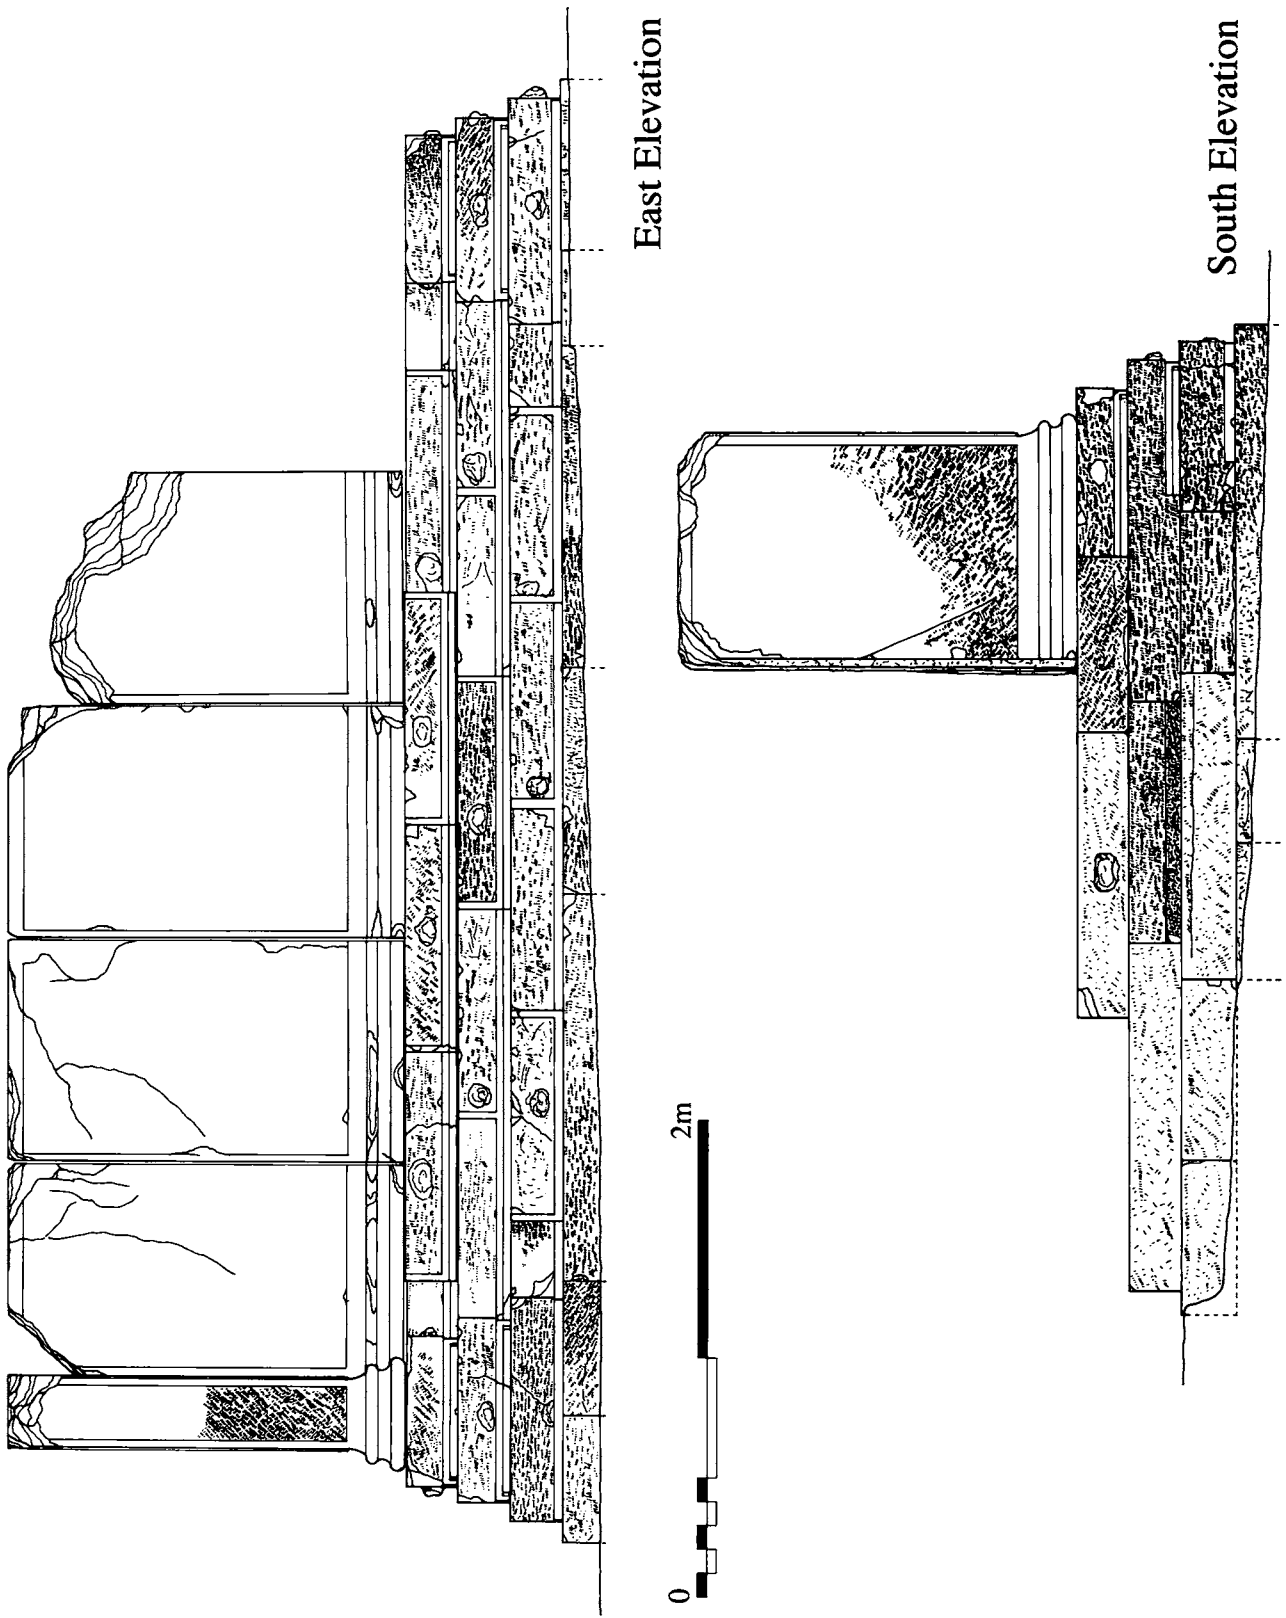
Fig. 3 K1, East and south elevations

There are five wall blocks in situ, which still stand on the east façade. (Pl. 5) Three of them are complete and two are damaged partially on the top. One of them was for the south wing wall. Their heights are 1.674-1.686 m,²⁾ lengths 0.900-0.990 m and widths uniformly 0.315 m. At their bottom is carved an Attic base molding with torus-scutia-torus, which was very well worked and preserved in very good condition. (Pl. 7) The outline of the wall blocks is articulated by being recessed along their vertical and horizontal joints. The depth of the recess is 0.060-0.070 m and the width 0.034-0.046 m along the sides and 0.063-0.070 m along the top. Thus, the wall blocks were outlined and articulated by recessed frames.

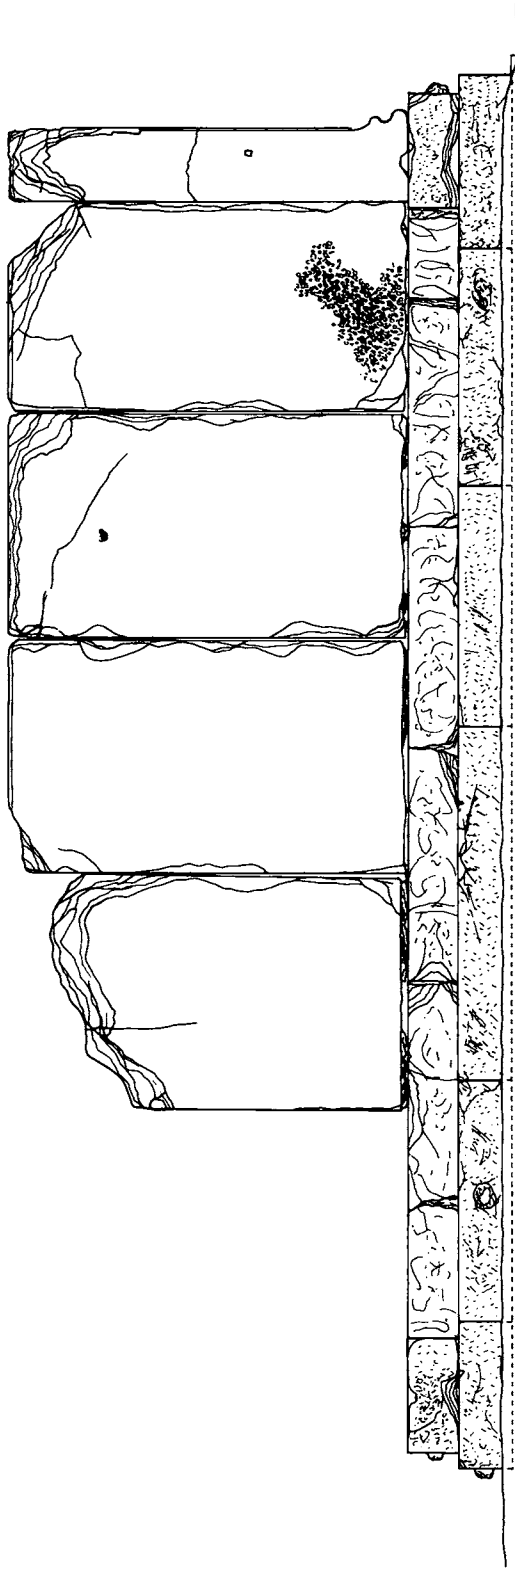
Fig. 4 K1, West and north elevations

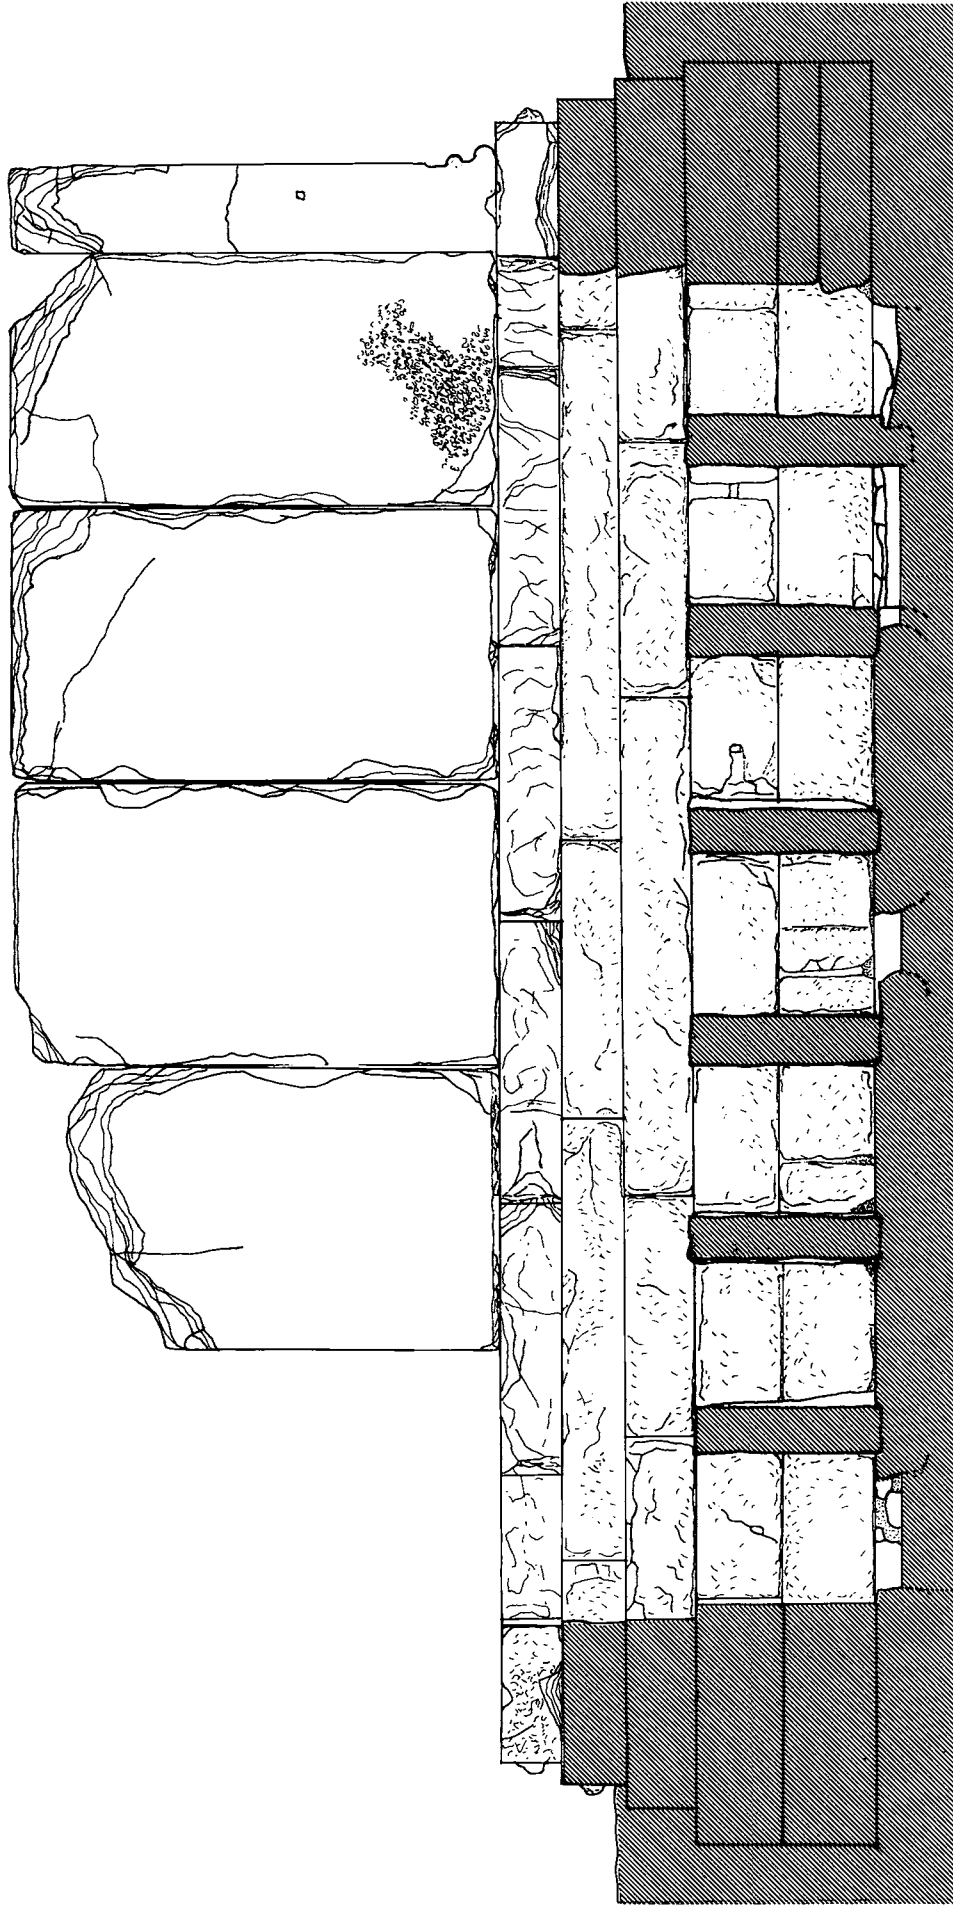
Fig. 5 K1, N-S section

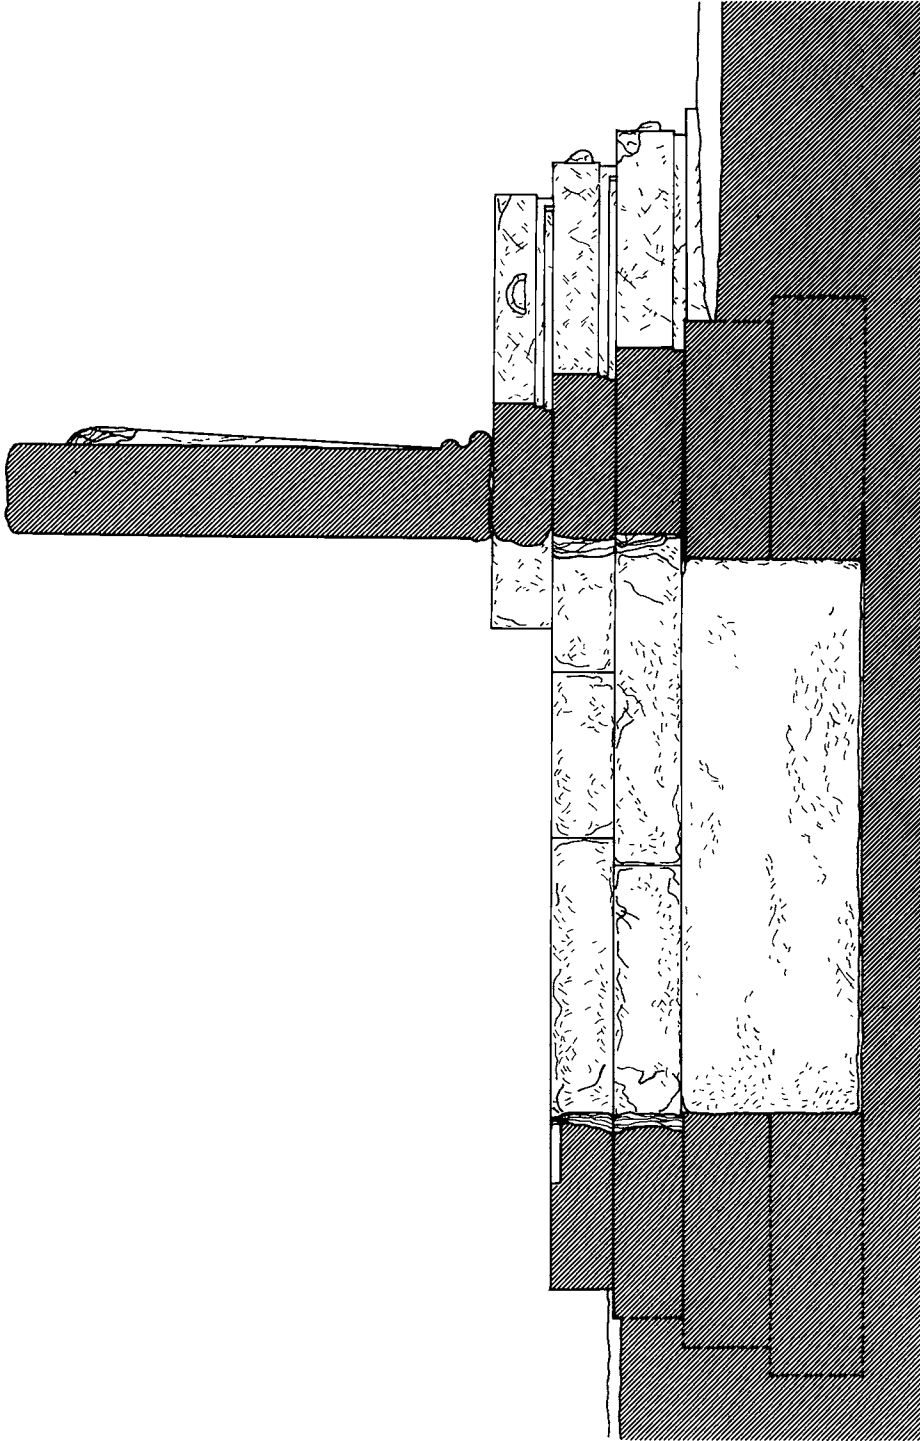
Fig. 6 K1, E-W section

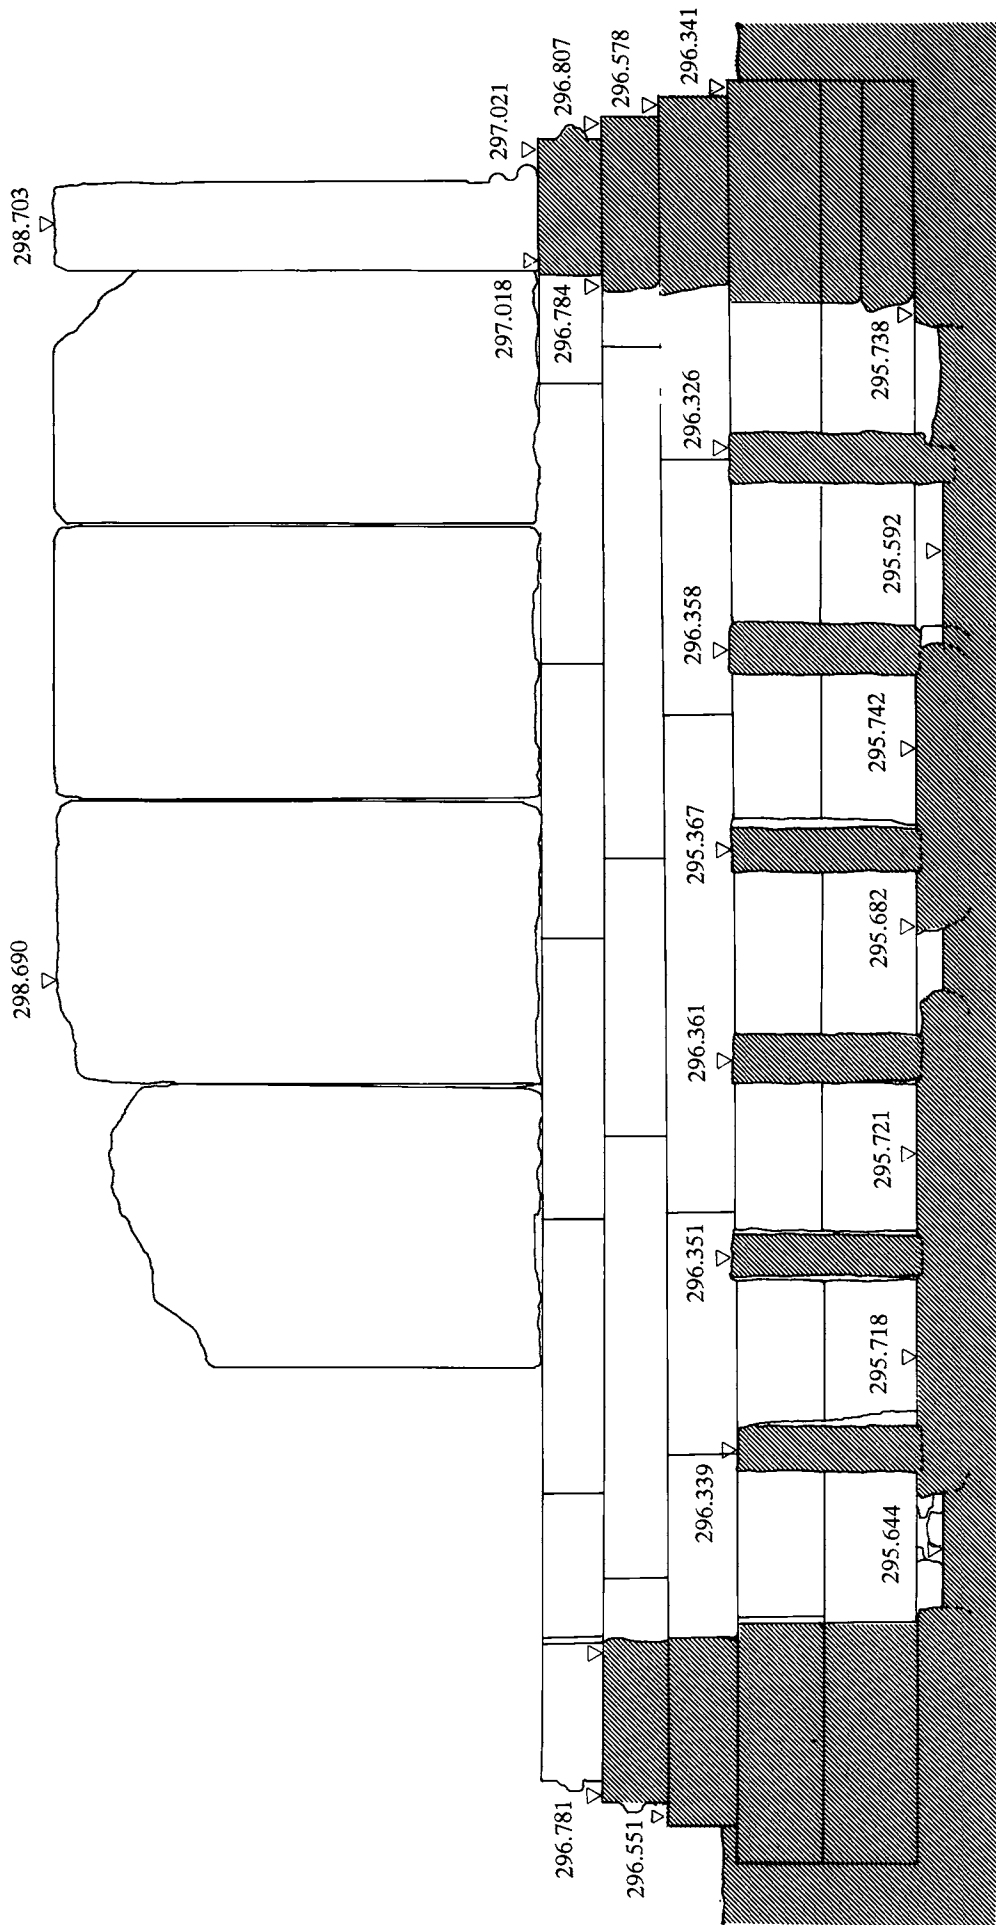
Fig. 7 K1, N-S section with levels

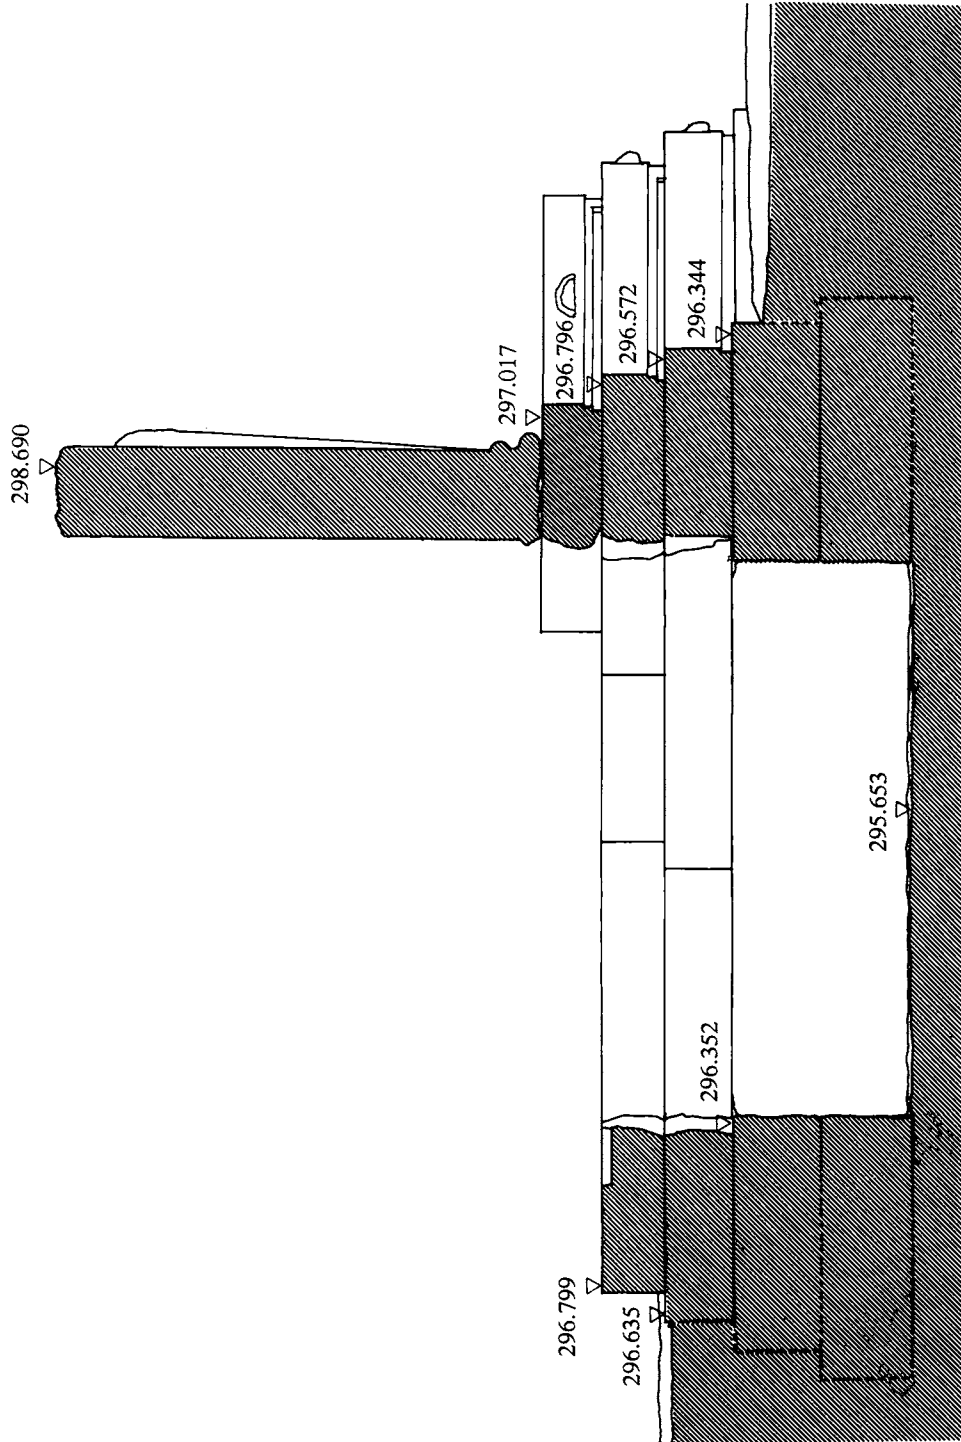
Fig. 8 K1, E-W section with levels

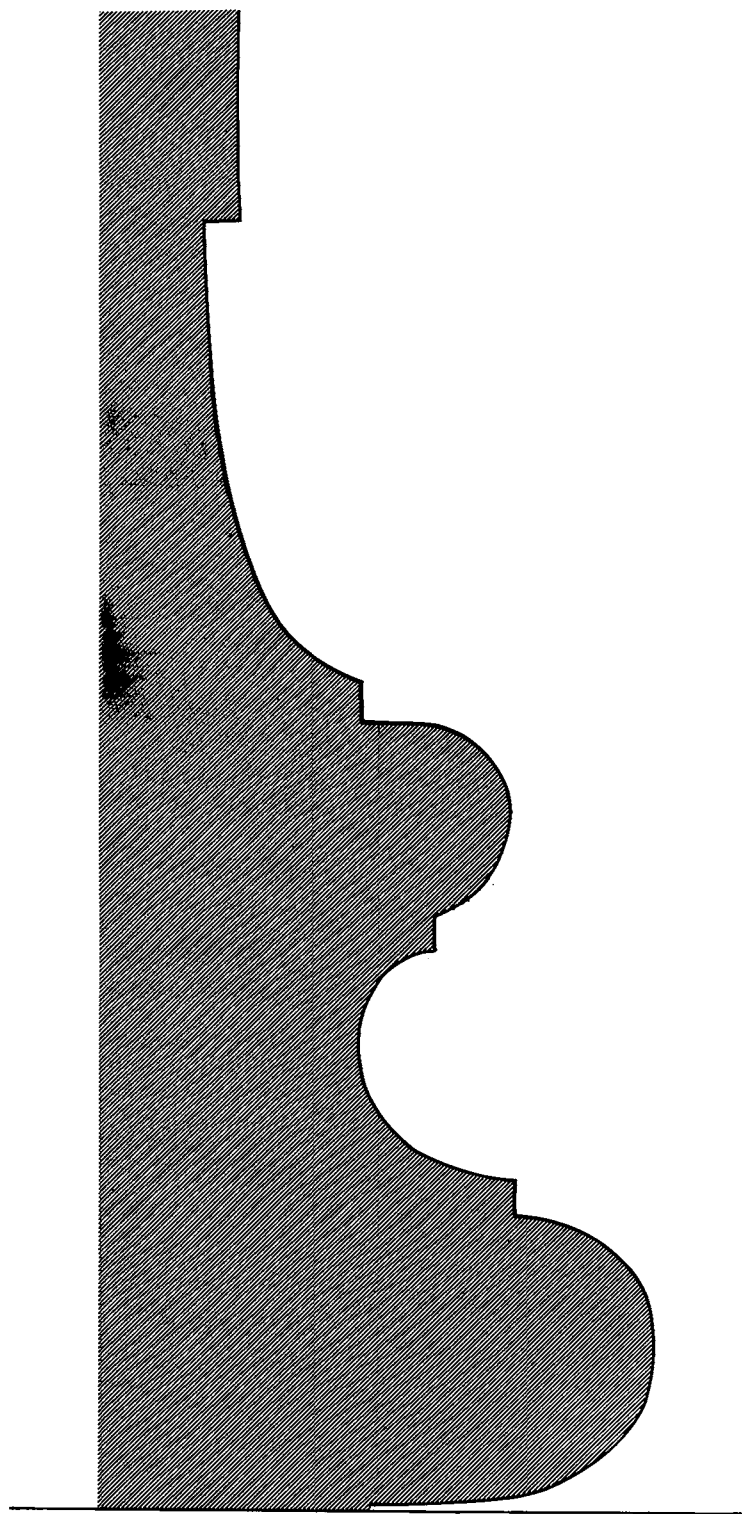
Fig. 9 K1, Molding of the wall base

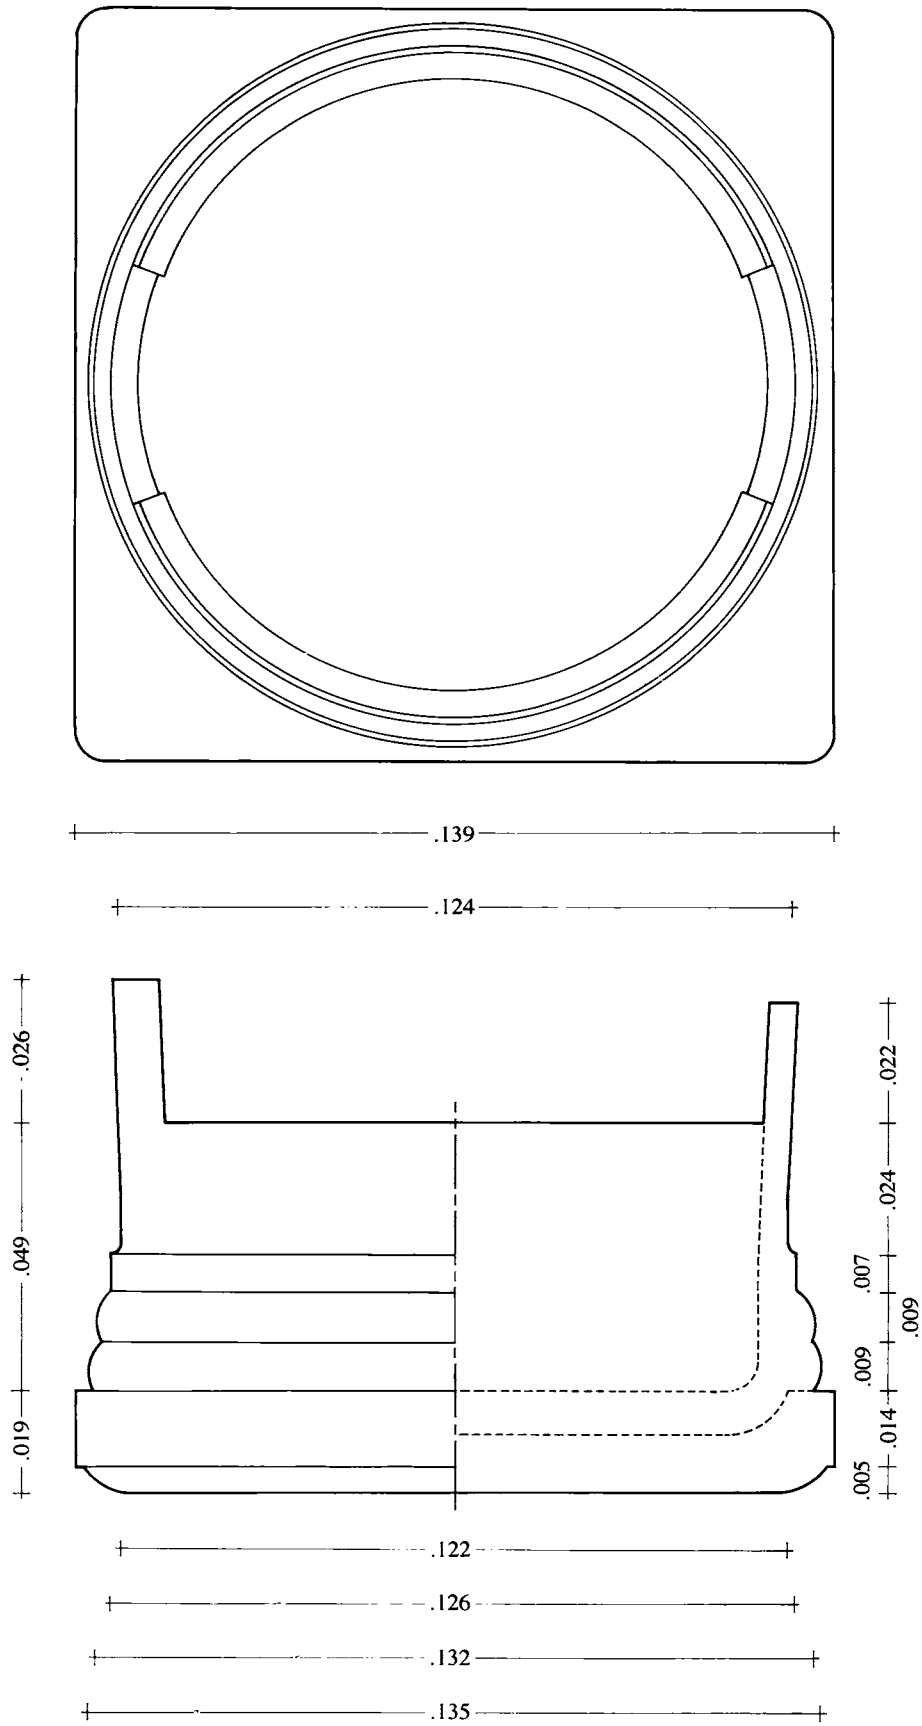
Door Socket

On the upper crepis of K1, there remain an original door socket and a pivot case of the door. ³⁾ (Fig. 10, Pl. 21) Both are of bronze and were found sticking together in-situ in a square shallow hole of the upper crepis of the doorway. After the excavation, they were taken to the museum and preserved in storage. (no. 9141) Evidently, they were used for smooth rotation of the door. The socket was fixed to the shallow square hole with lead which is 1.5 - 3.5 cm thick. Inside the pivot case remains a fragment of the bottom of the lime stone door post. It is recognizable that the interstice between the lime stone and the pivot case was also filled with lead. The exterior diameter of the cylindrical pivot case is 123.5 mm at the top, and 134.5 mm on the bottom. The interior diameter is 108 - 114 mm. The thickness of the case is 4 - 7 mm. As for the profile, the upper half is smooth and the lower half is of two courses of torus. There are two square notches on the top of the case to fix it to the limestone door post; one is 22 mm and the other 26 mm. The socket is 139 mm square and 14 mm thick. On the bottom, there is a round swell which is 5 mm thick and 136 mm in diameter.

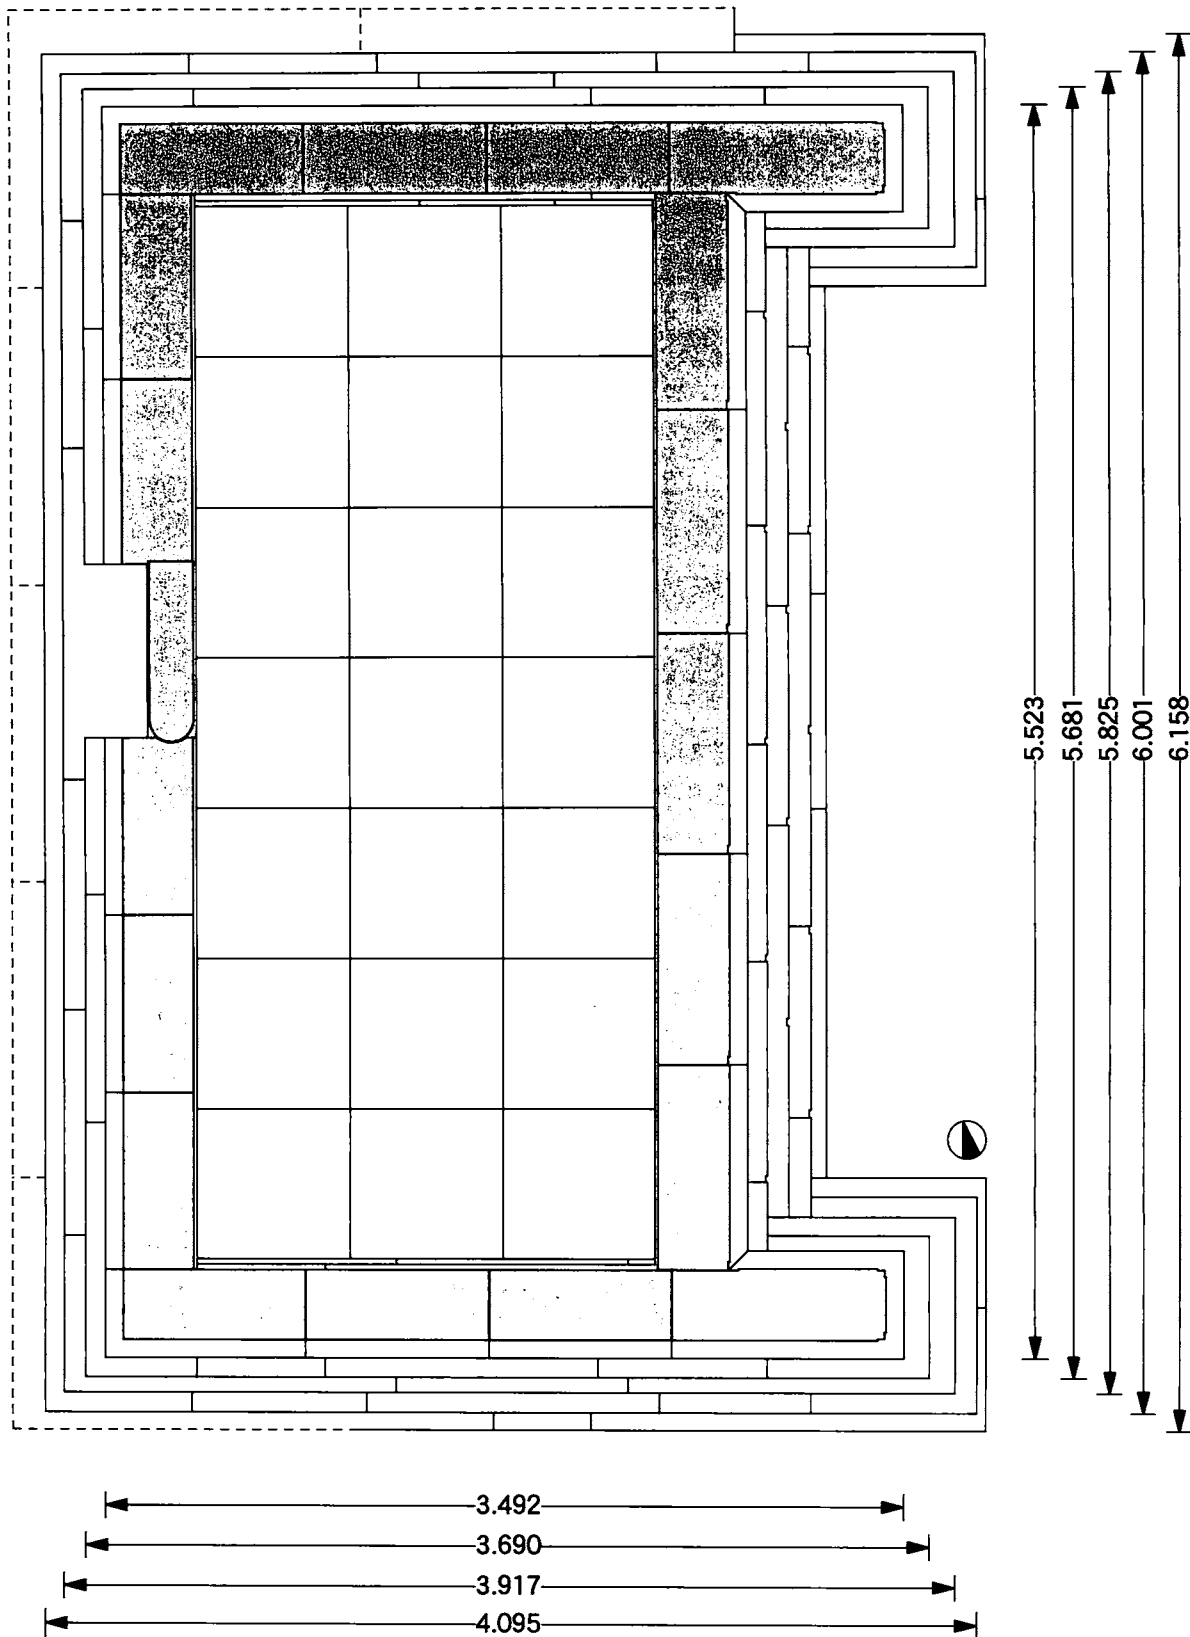
Fig. 13 K1, Plan reconstructed

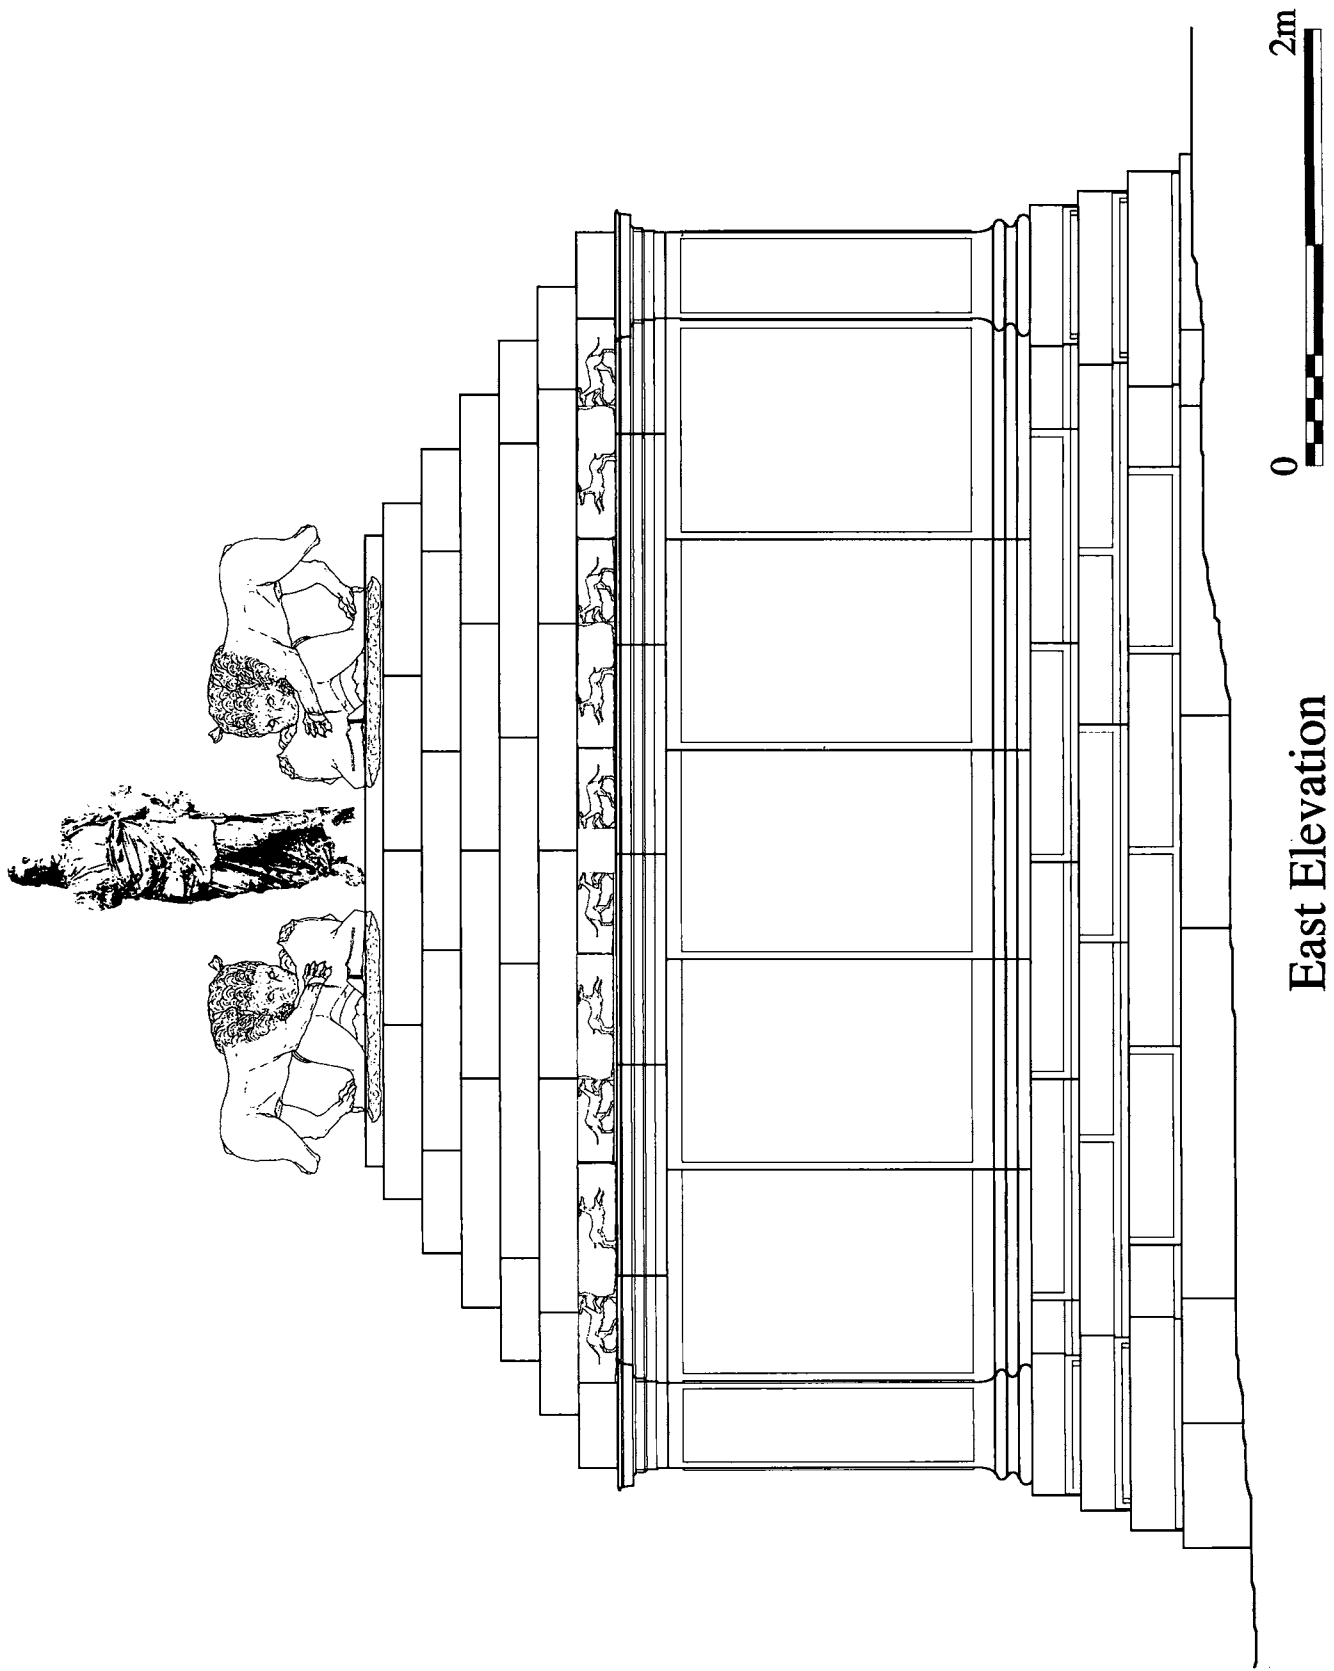
Fig. 14 K1, Trial reconstruction of the east elevation

It is difficult to reconstruct the upper part of K1 accurately as only a few architectural blocks were found. For the roof in particular, there was no block which we could identify. However, it was probably not very different from K3 which was able to be reconstructed in almost complete form. Specifically, it must have been crowned with a cornice on the wall and then the roof. On the top of the roof, a group of sculptures was probably placed, judging from the fact that a sculpture of a lion attacking a deer was found in the tomb chamber. (Fig. 14, 15)²⁶⁾

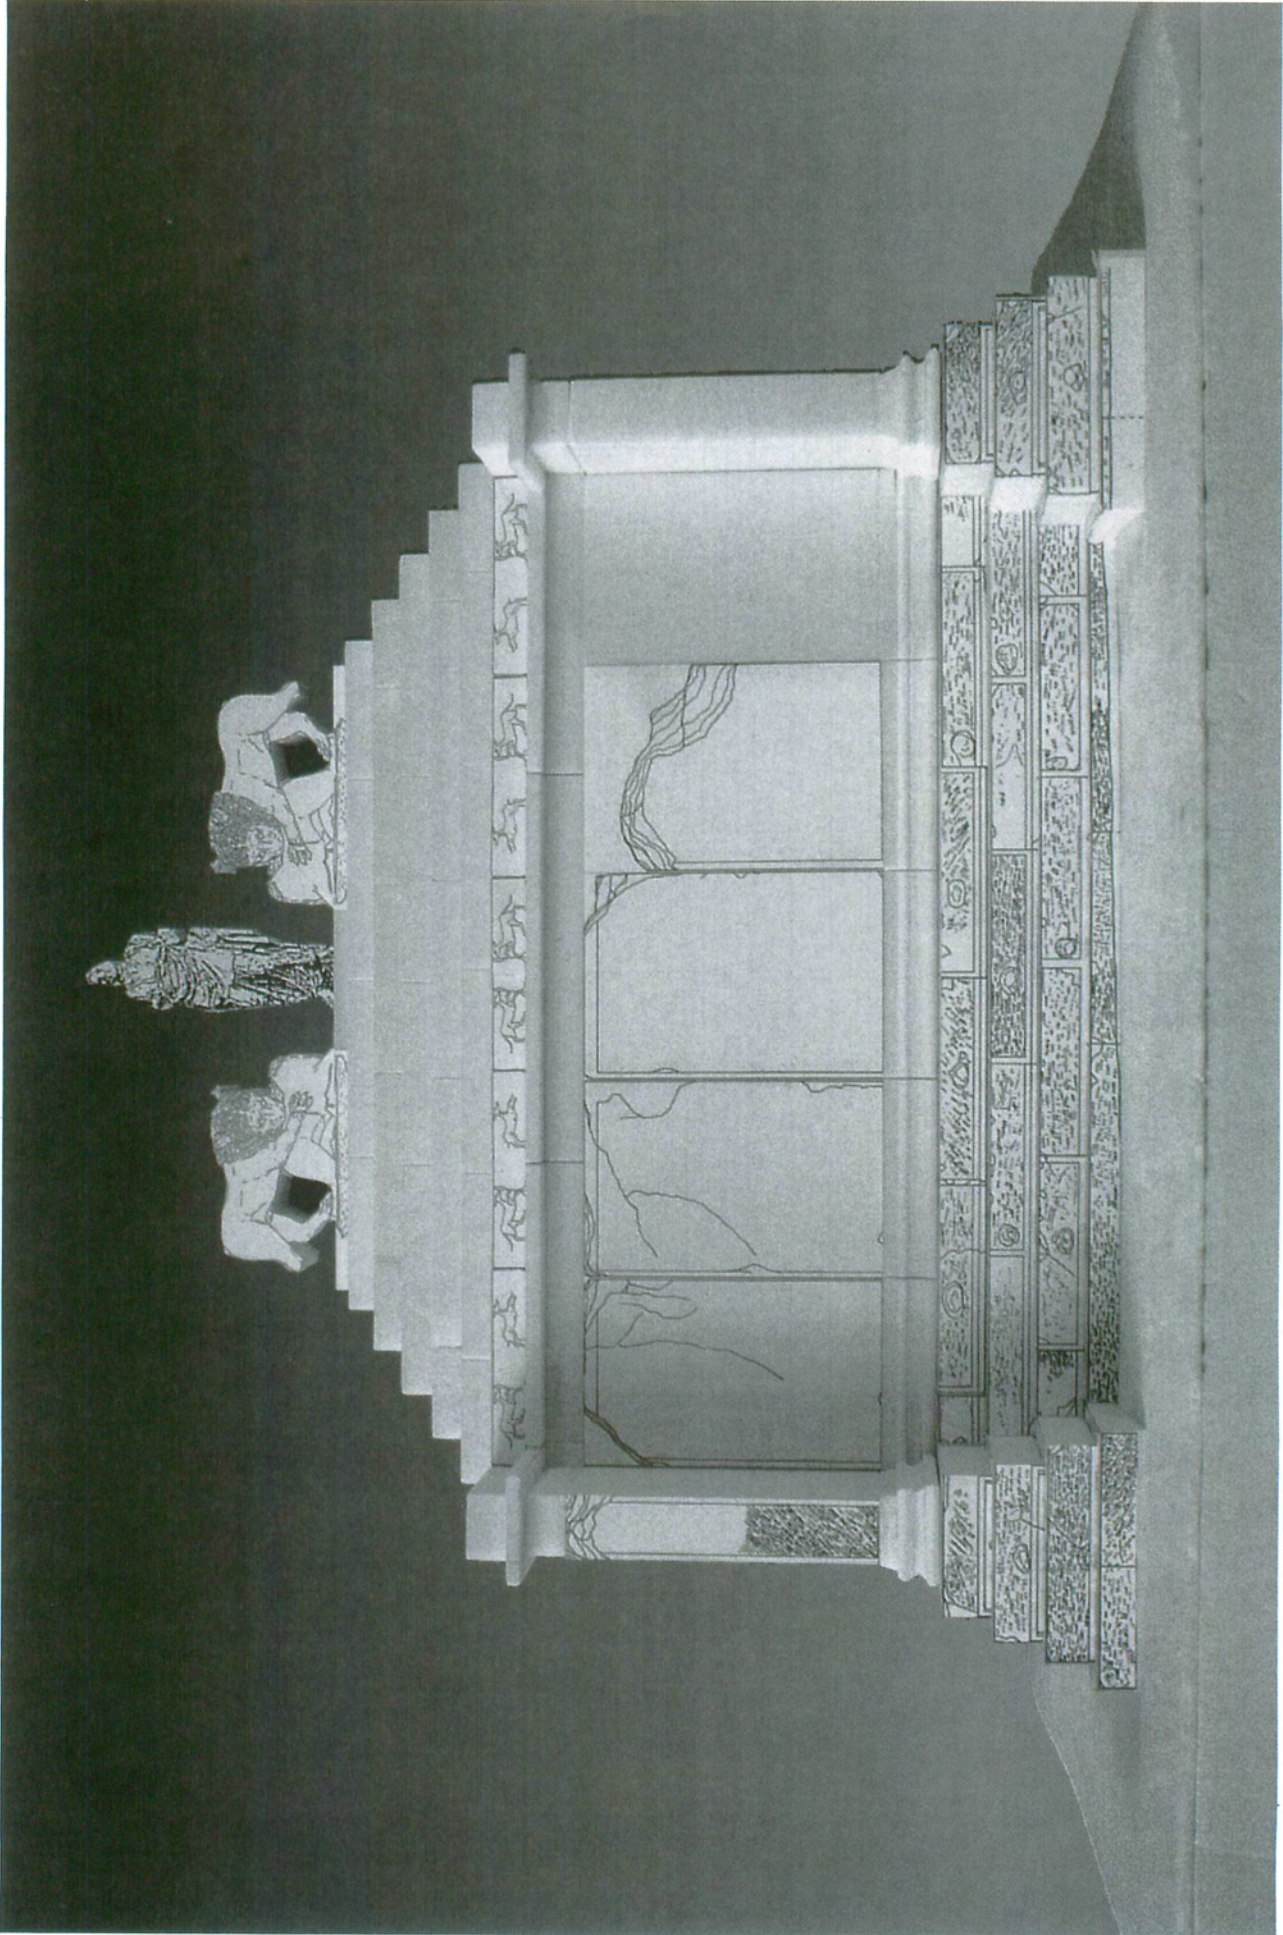
Fig. 15 K1, Model, view from the east

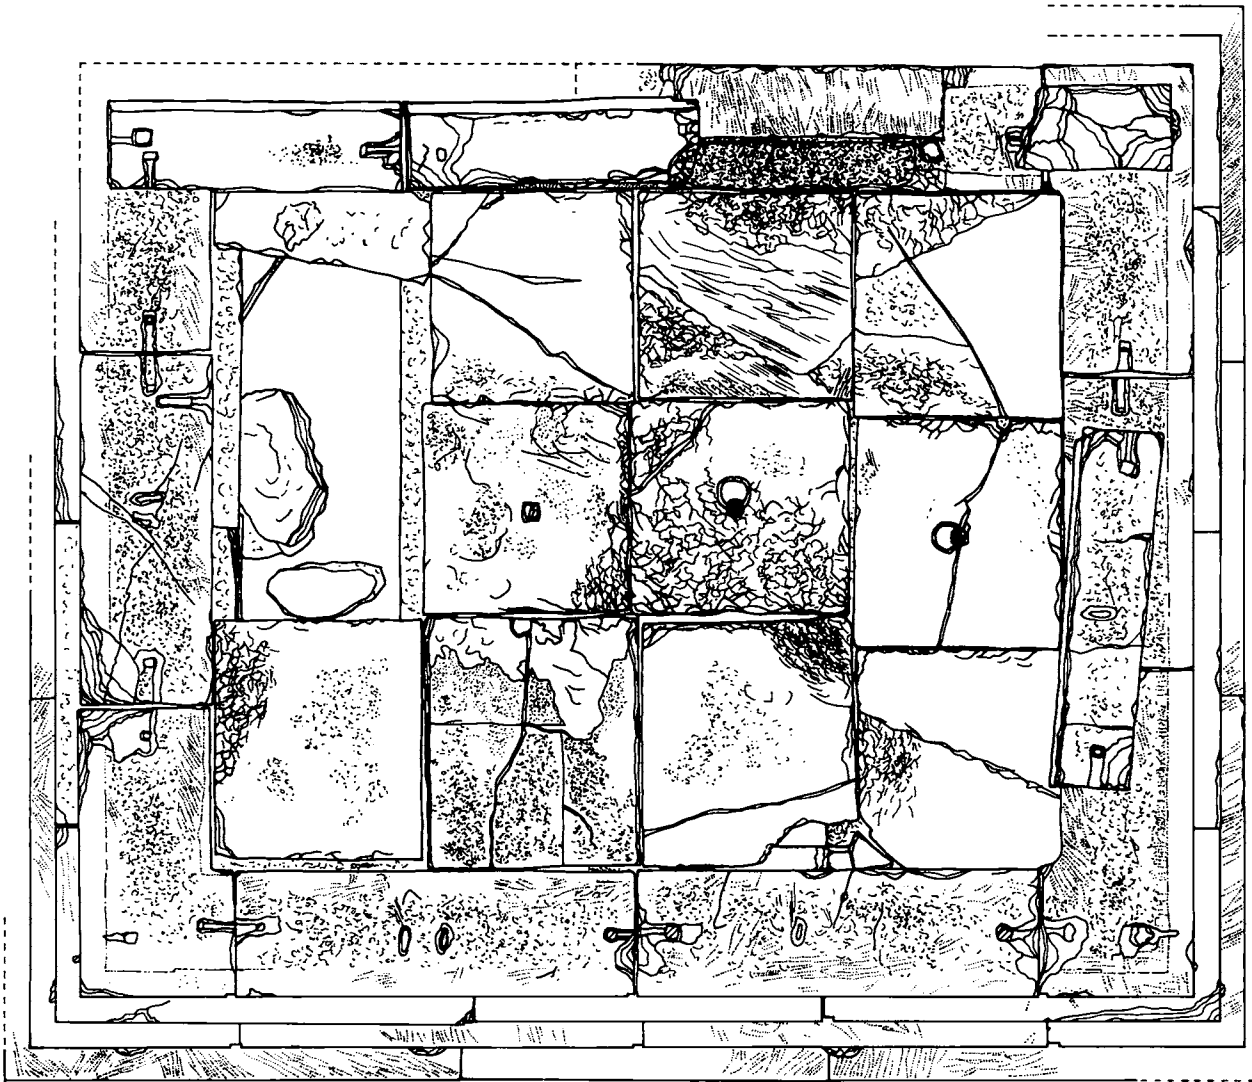
Fig. 16 K2, Plan
