**ARCHITECTURAL STUDIES OF THE THREE GRAVE MONUMENTS
IN THE GYMNASIUM COMPLEX AT ANCIENT MESSENE**

Preliminary Report

Juko Ito

**Architectural Mission to Greece
Kumamoto University, Japan**

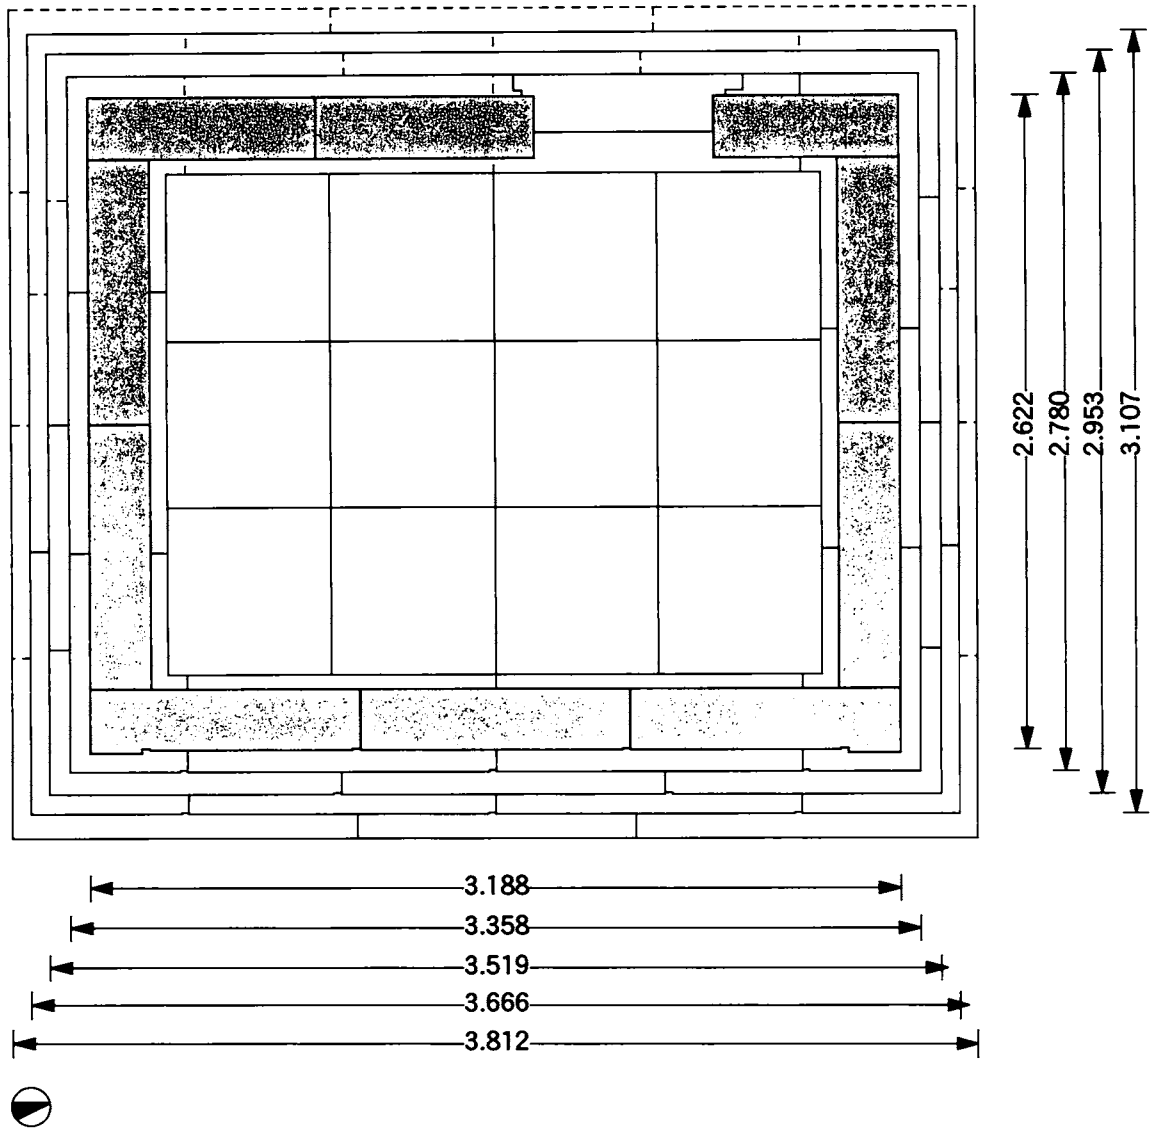
Fig. 17 K2, Plan reconstructed

The superstructure of K2 is missing except for two cornice blocks, in contrast to the platform which has been preserved completely. Thus, it is very difficult to reconstruct the superstructure, and the reconstruction remains a matter of conjecture, especially for the roof.

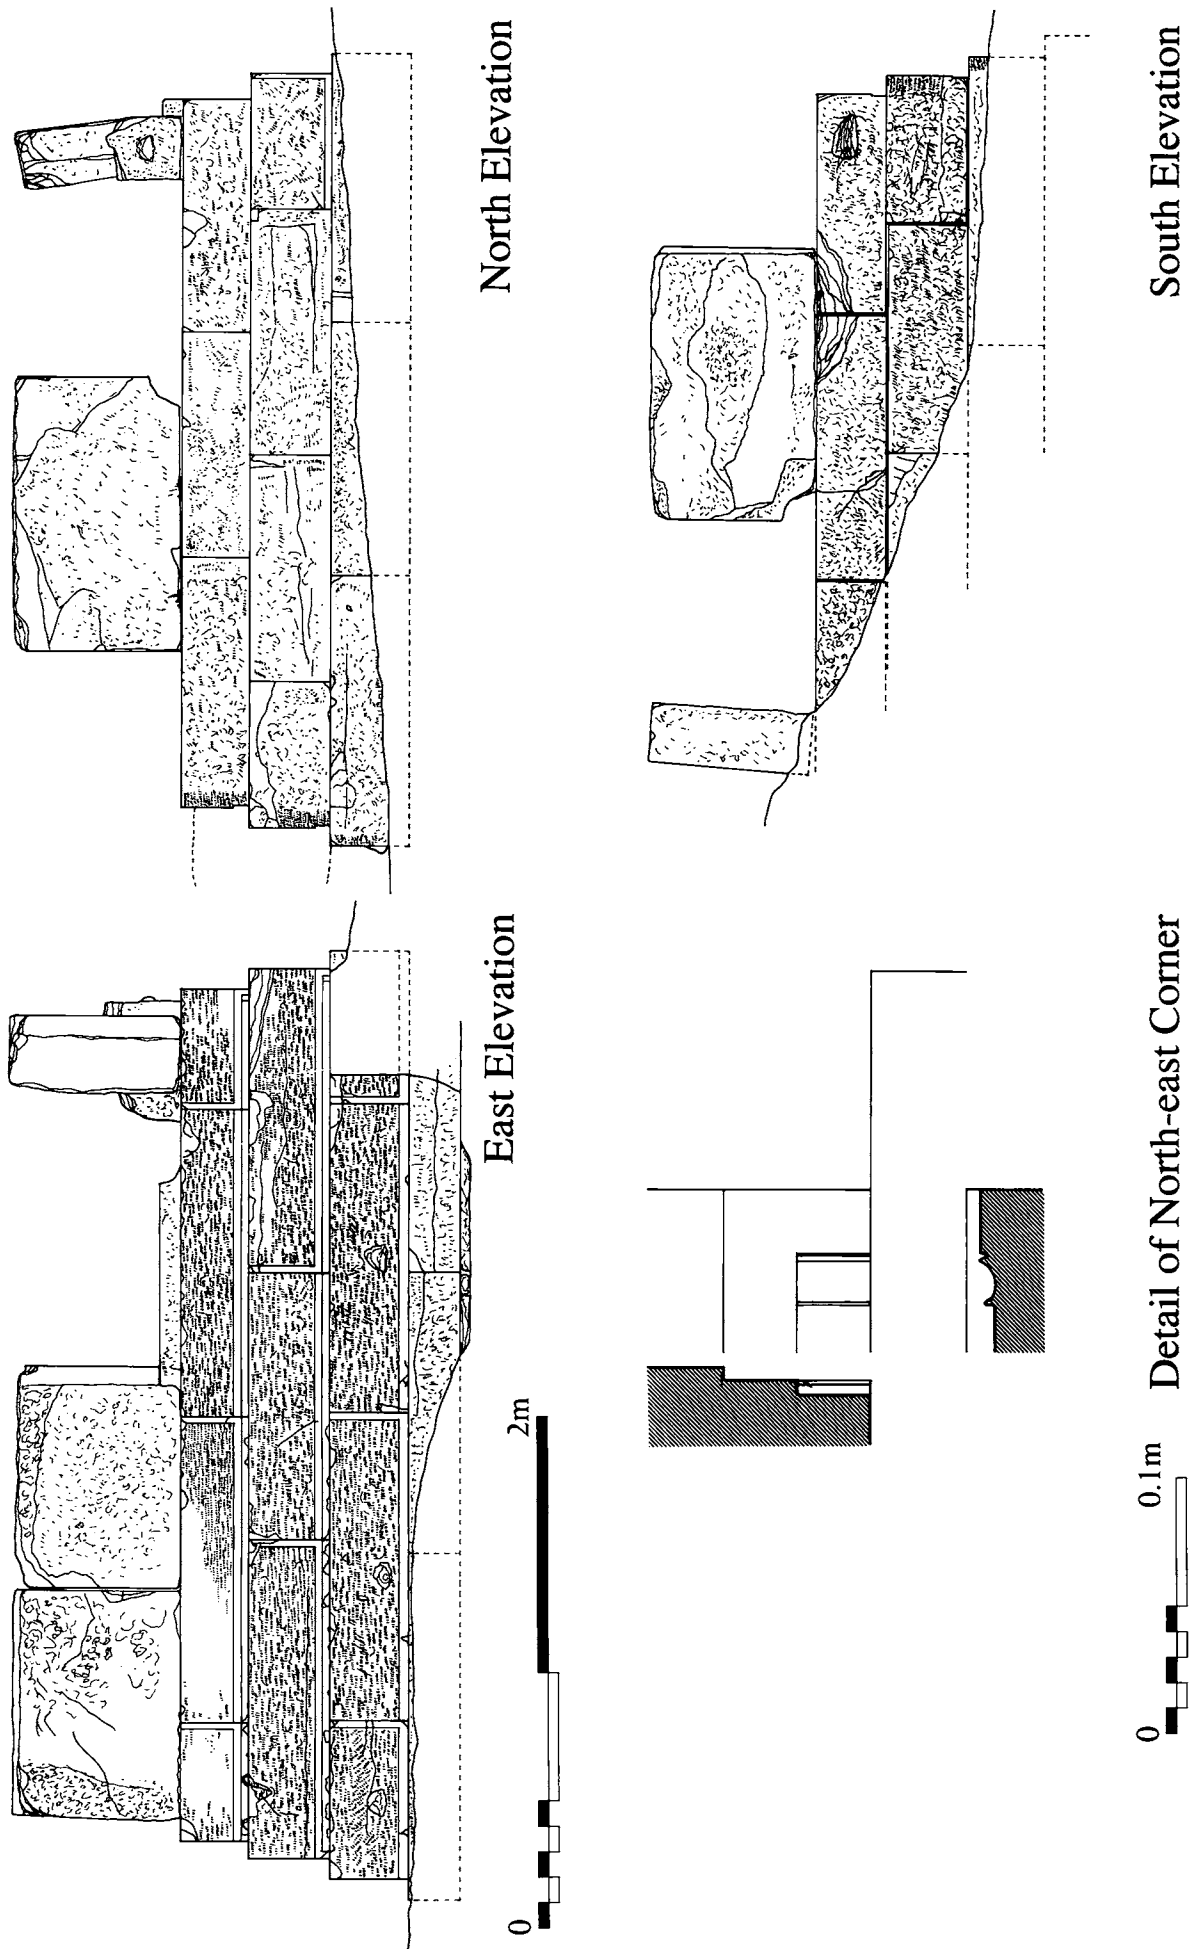
Fig. 18 K2, East, north and south elevations, a detail of relieving margin

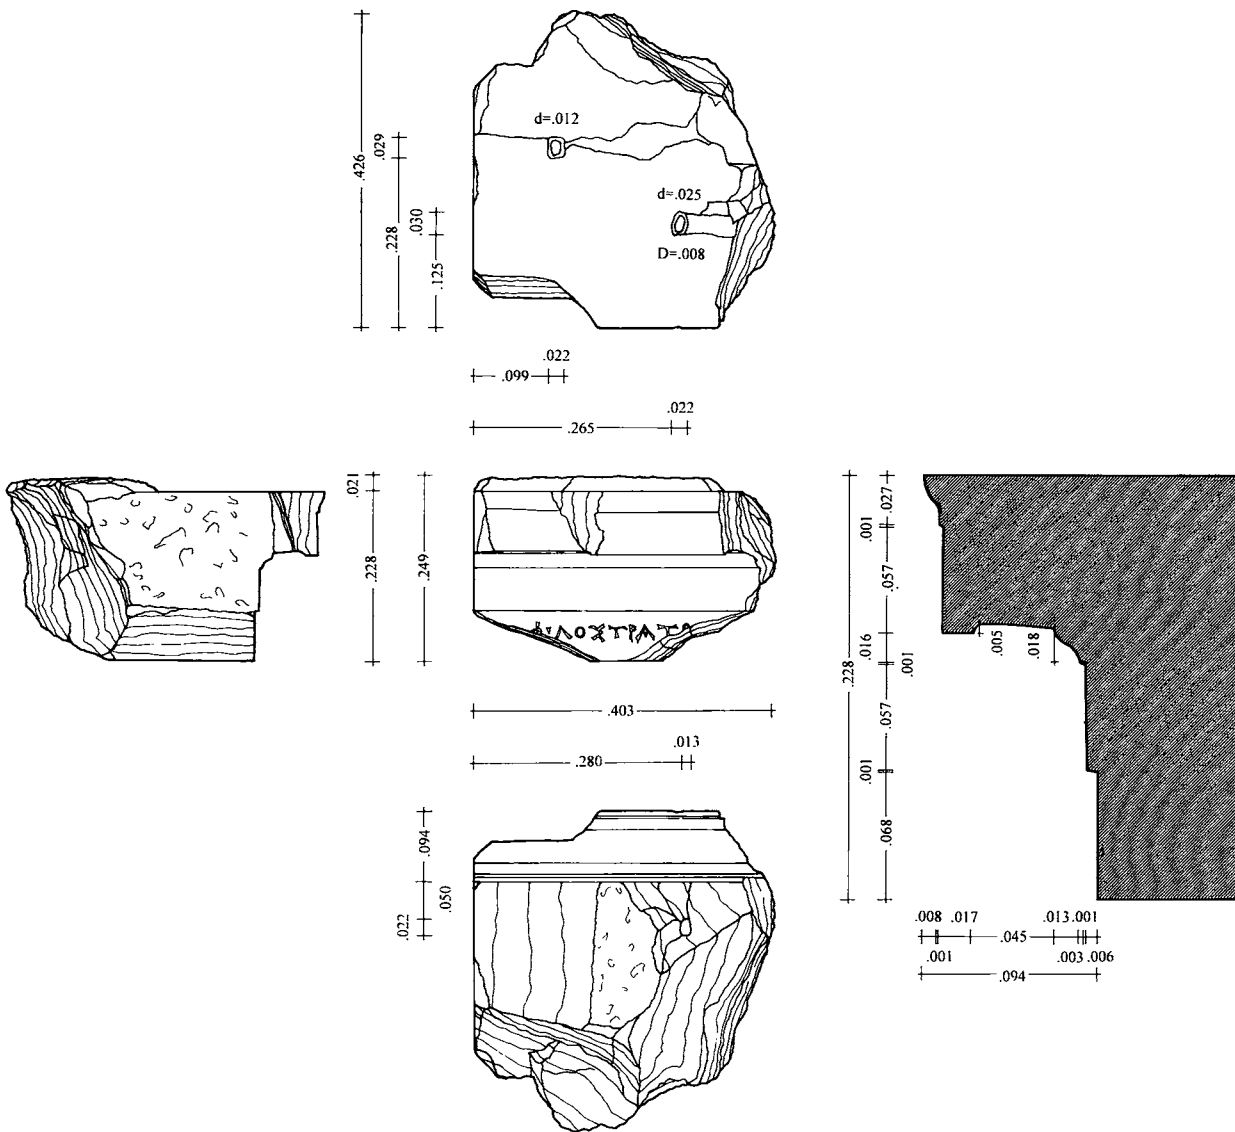
K2.2

Fig. 22 K2, Fragmentary cornice block with an inscription

Cornice block. Although the corners are broken, the original size is mostly maintained. On its top, a clamp hole and dowel hole are recognizable. There is also an inscription on the lower fascia which says **ΦΙΛΟΣΤΡΑΤ [ΟΣ]**.

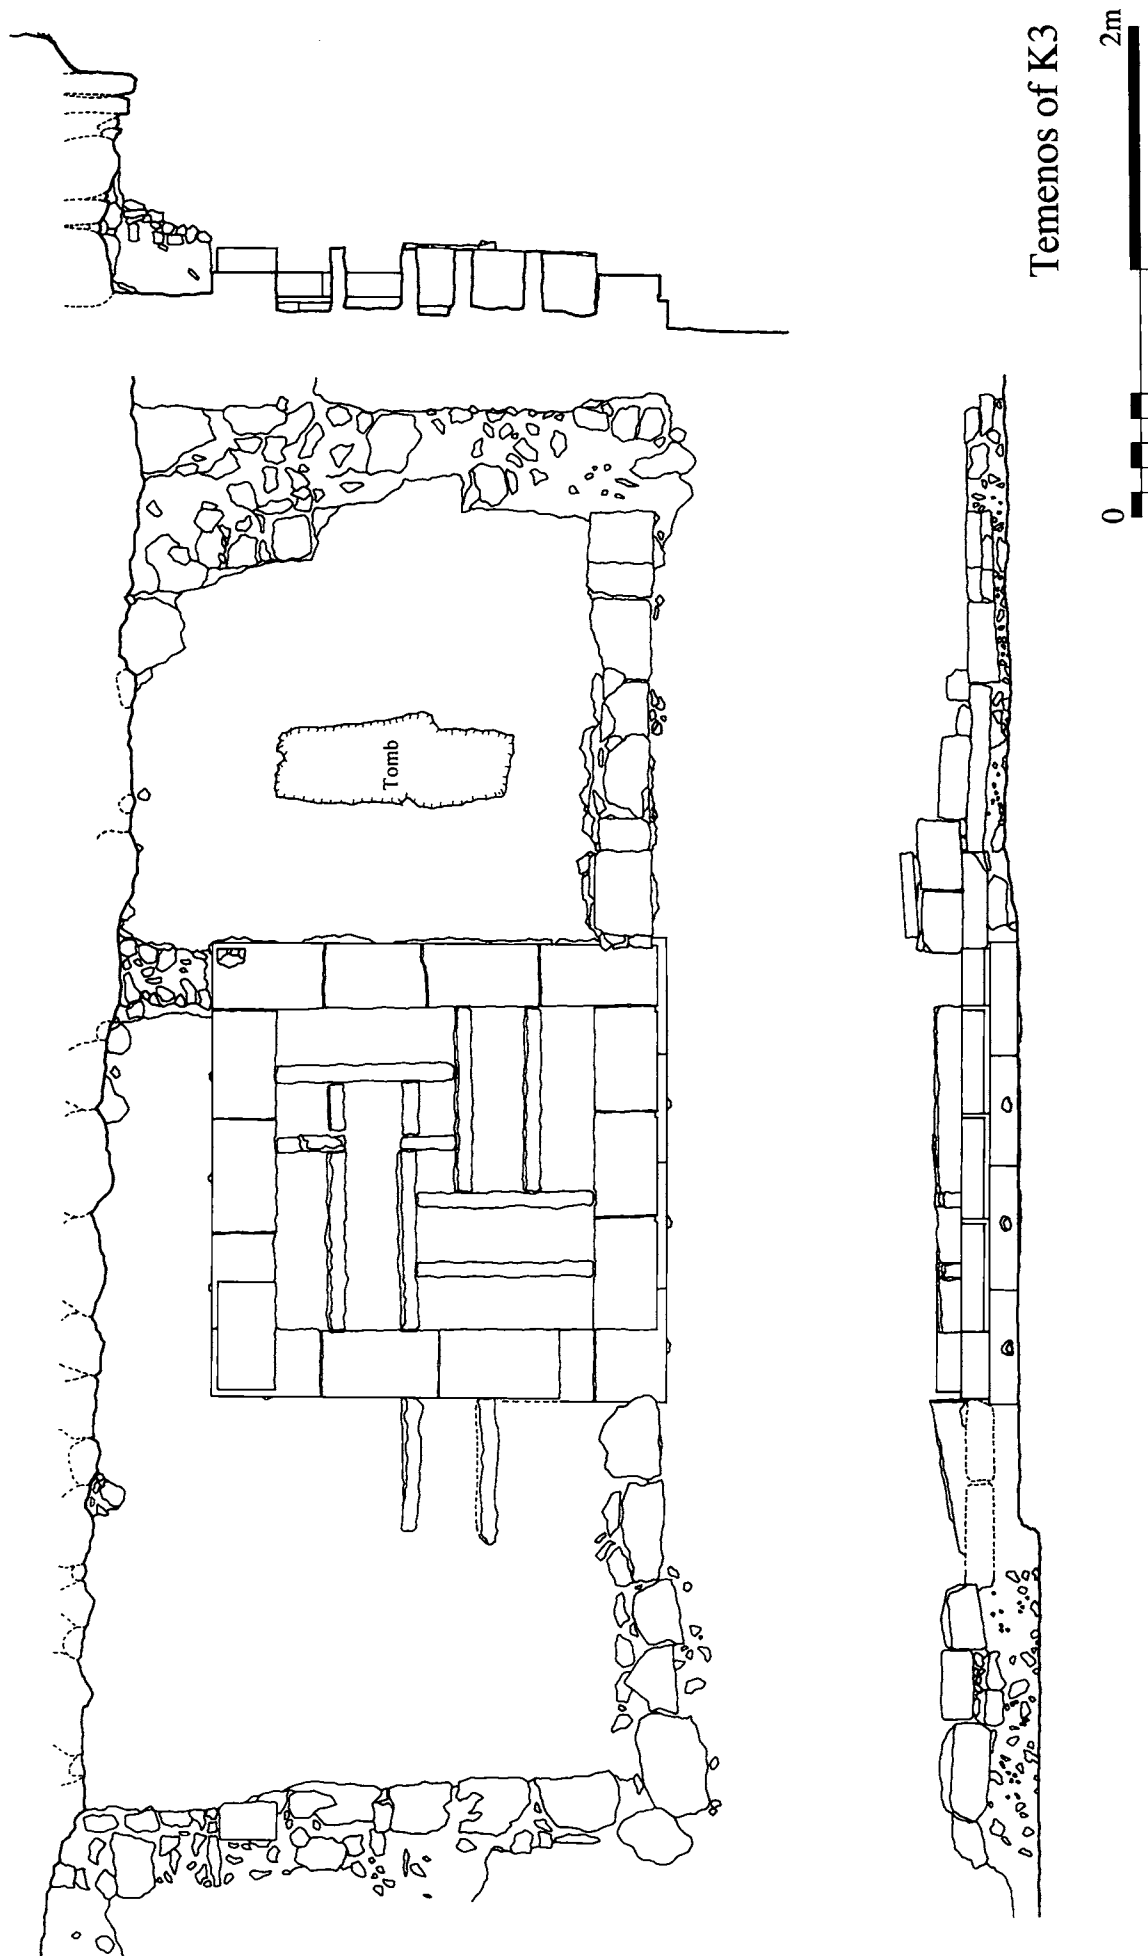
Fig. 23 K3 and its enclosure, plan

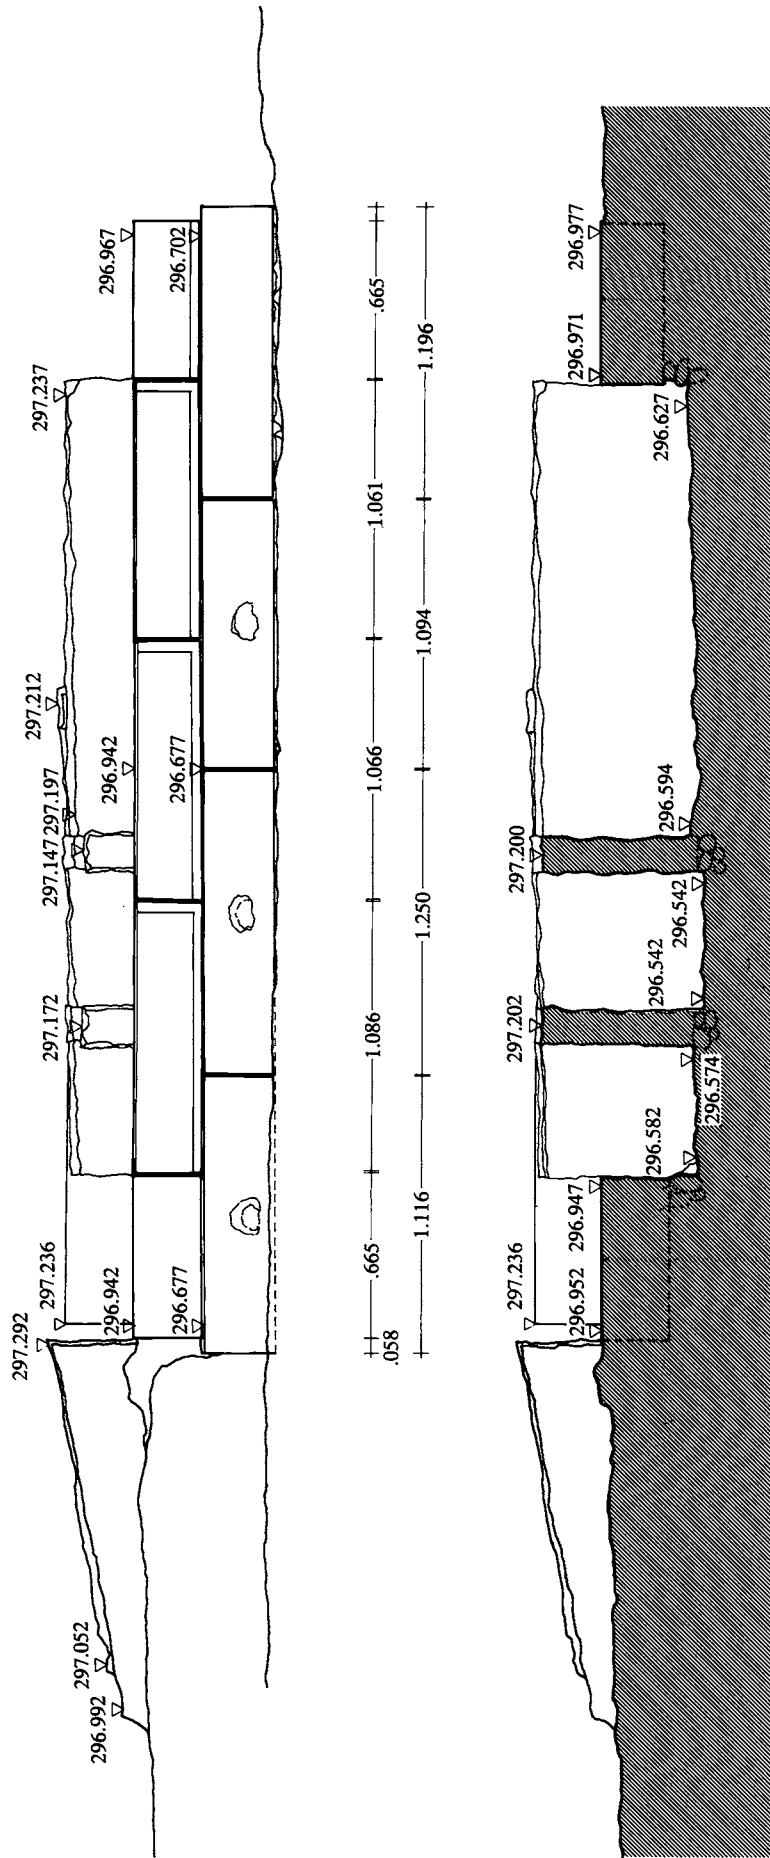
Fig. 26 K3, East elevation, N-S and E-W sections with dimensions and levels

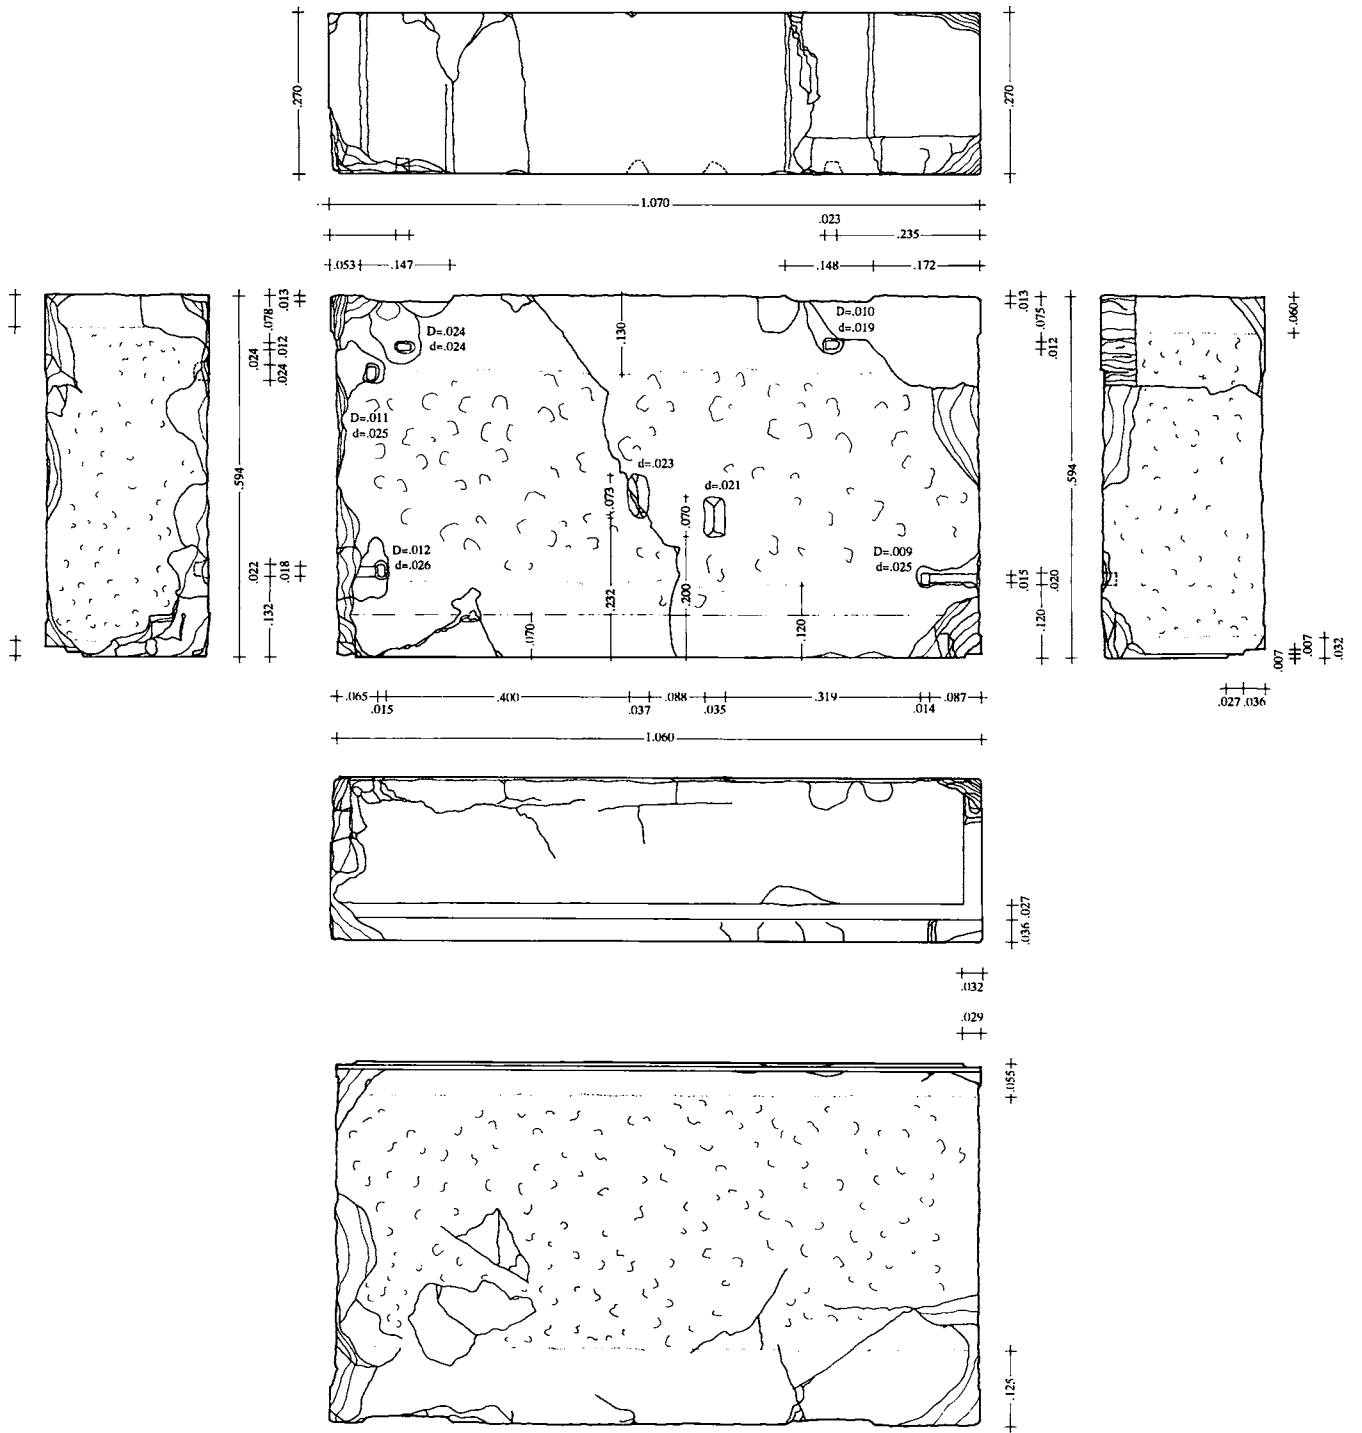
XI.78a,b

Fig. 27 K3, Upper crepis block, XI.78a, b

We found 18 upper crepis blocks. Their height varies from 0.267 m to 0.283 m, and the depth from 0.592 m to 0.605 m. Three of the blocks XI.78, K3.68, and XI.29 have a double relieving margin and a recessed joint at the right side of the exterior surface. The small fragmentary block K3.70 shows a trace of a double relieving margin. These blocks must have been placed on the east side to be seen from the street. For the other blocks of the upper crepis, there is neither relieving margin nor recessed joint.

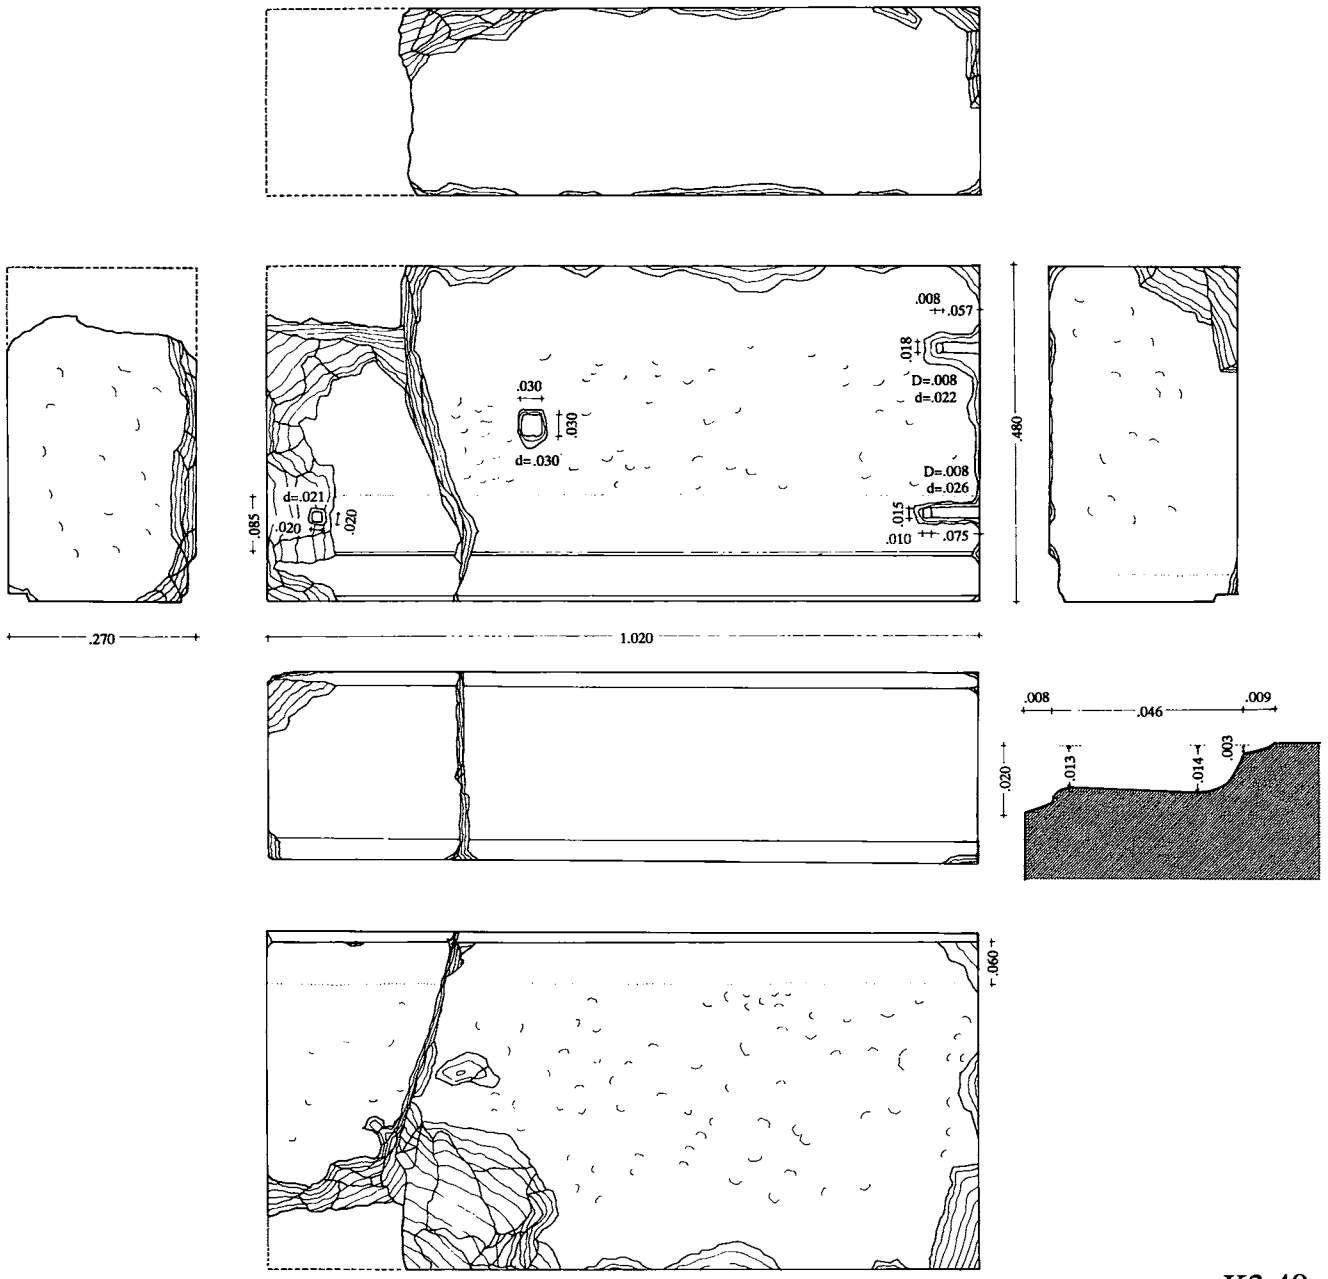
Fig. 28 K3, Toichobate block, K3.49

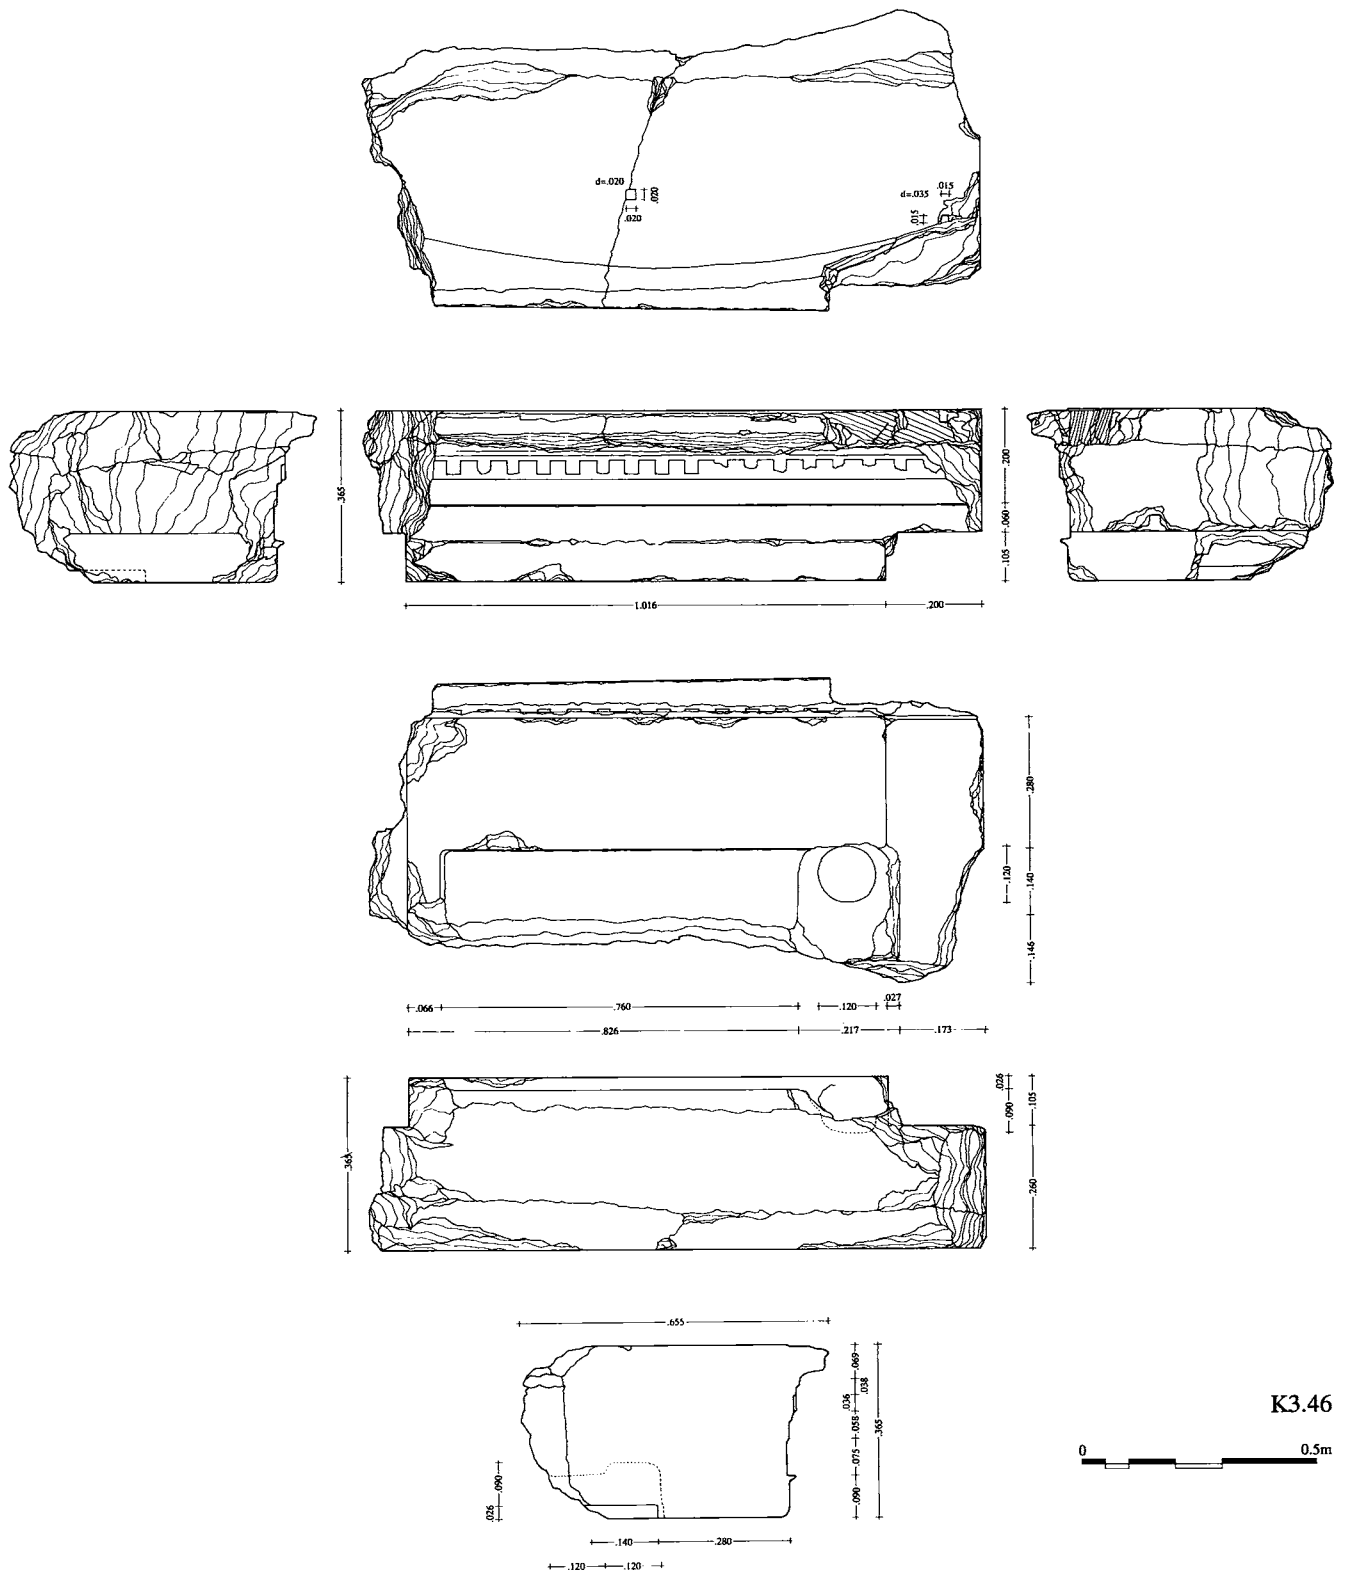
Fig. 32 K3, Cornice block with lintel for doorway, K3.46

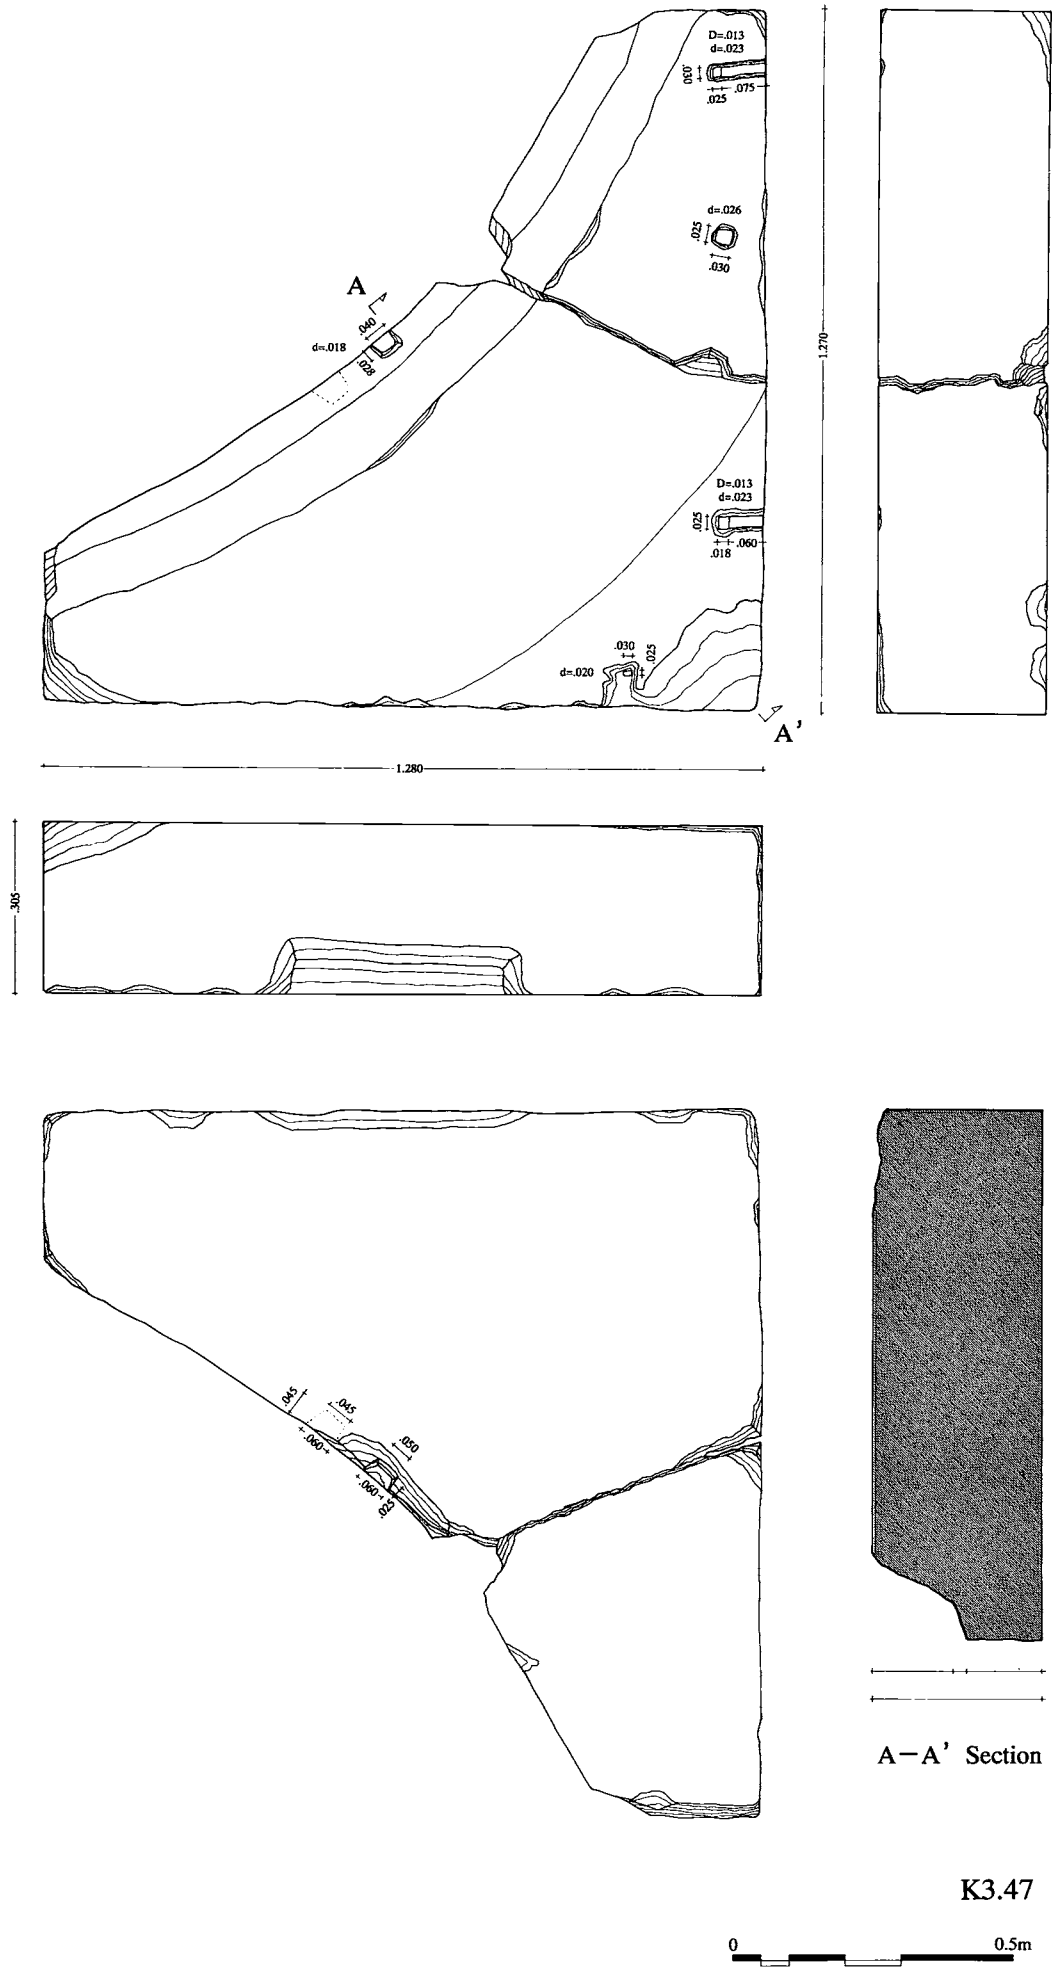
Fig. 34 K3, Ceiling block, K3.47

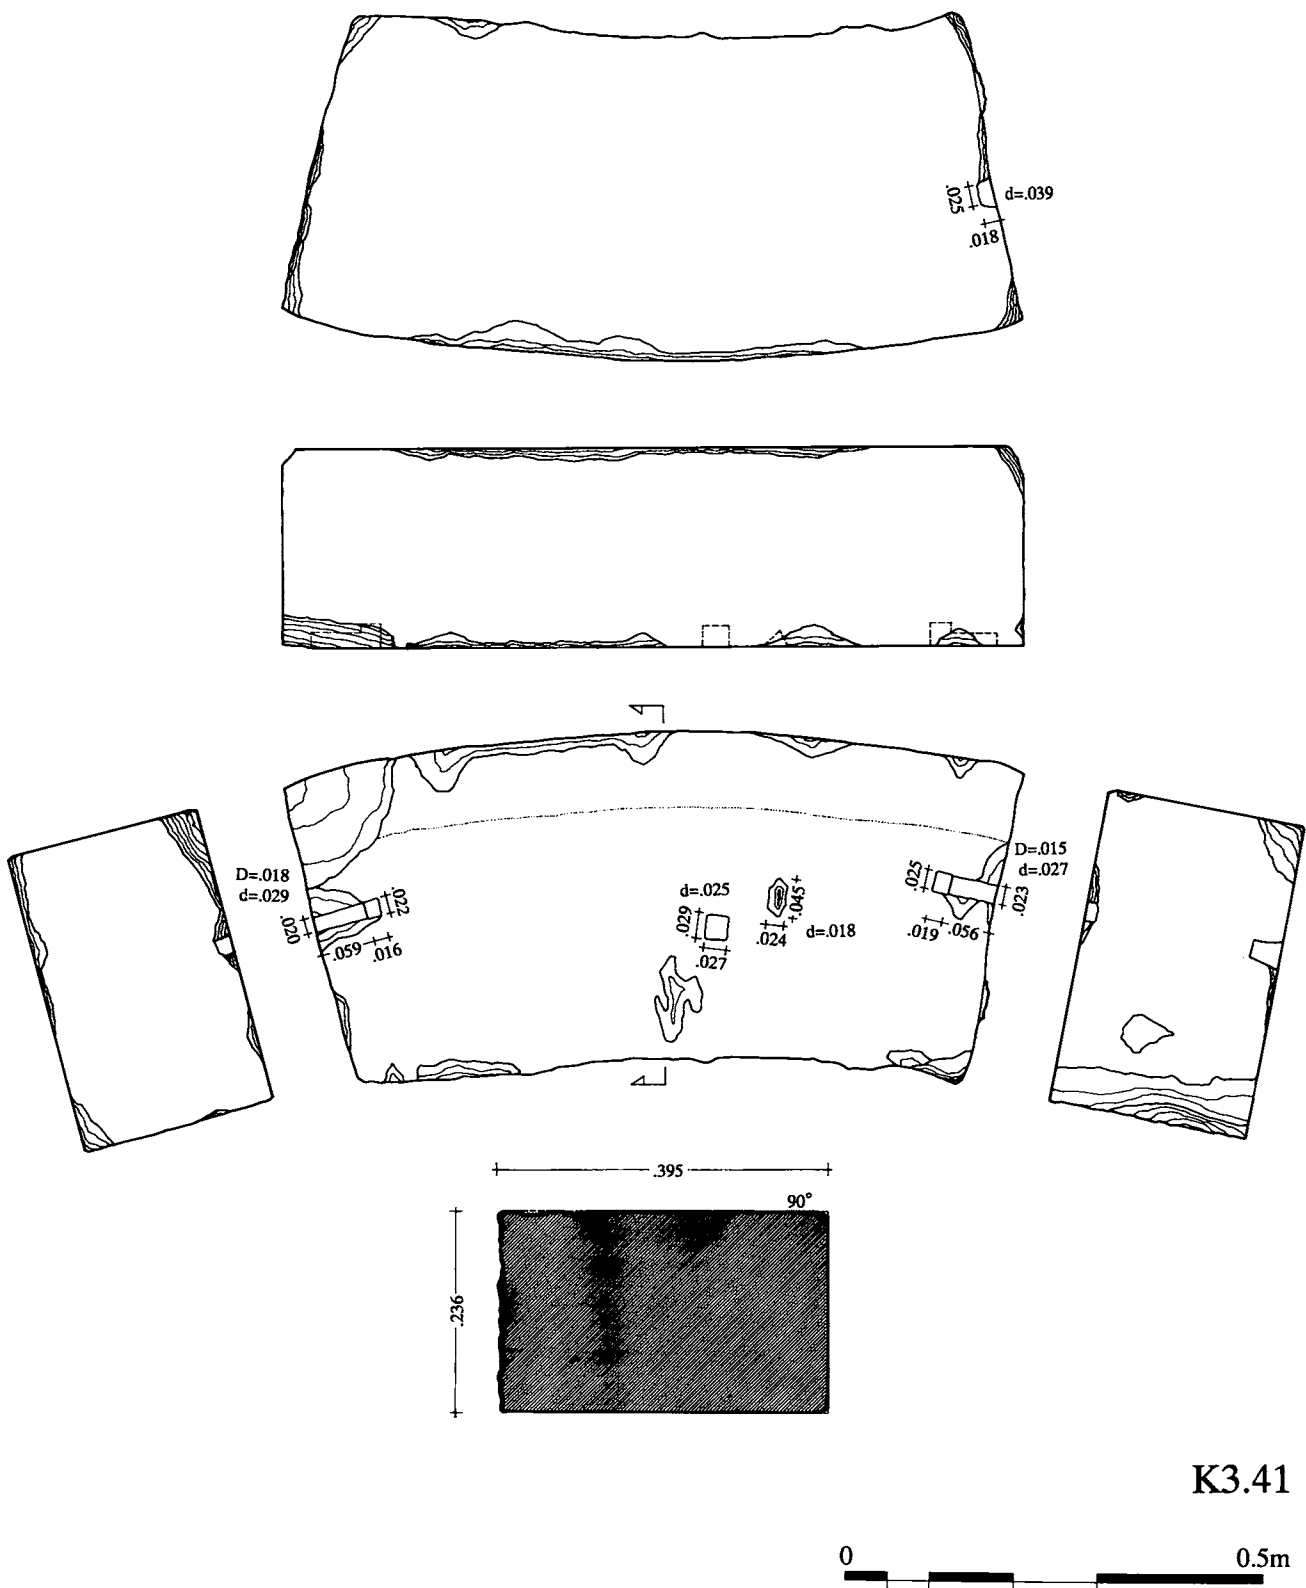
Fig. 35 K3, Roof block of the bottom course, K3.41

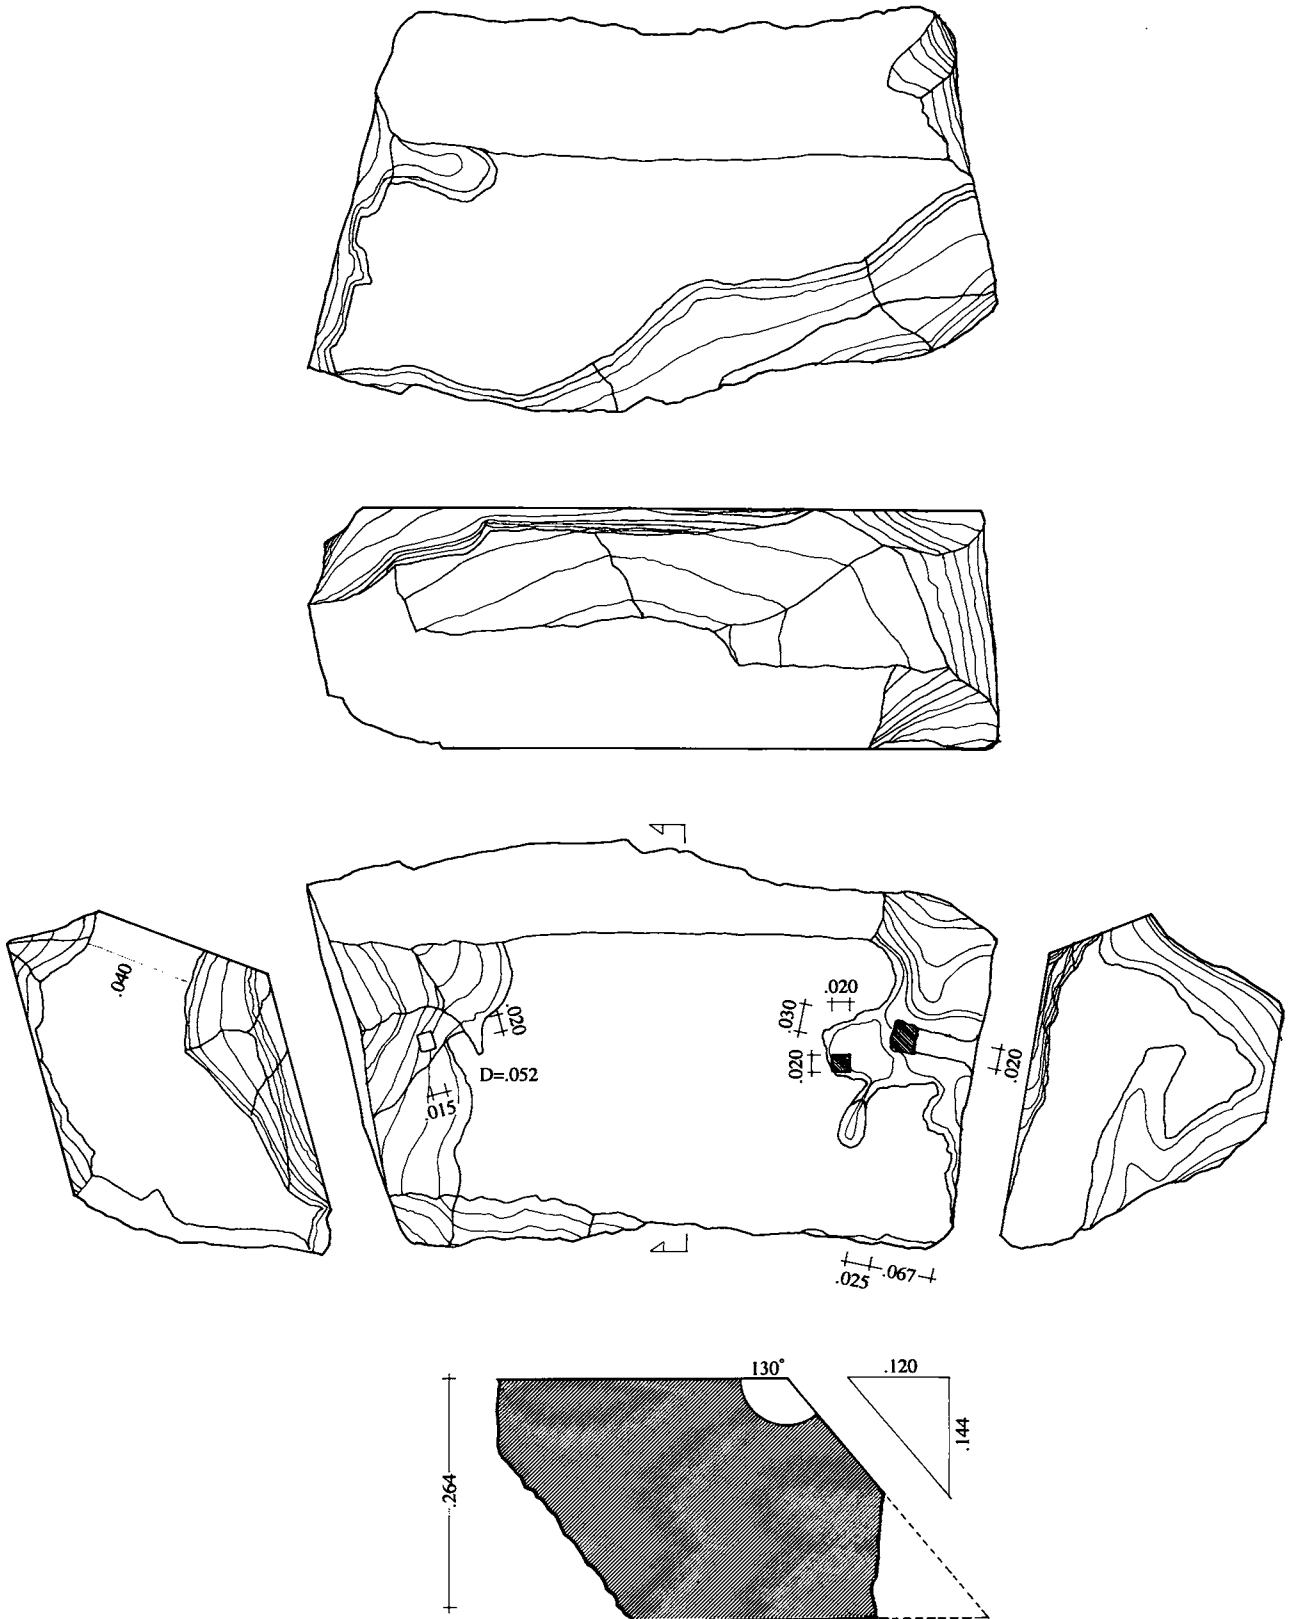
Fig. 36 K3, Roof block, XI.92

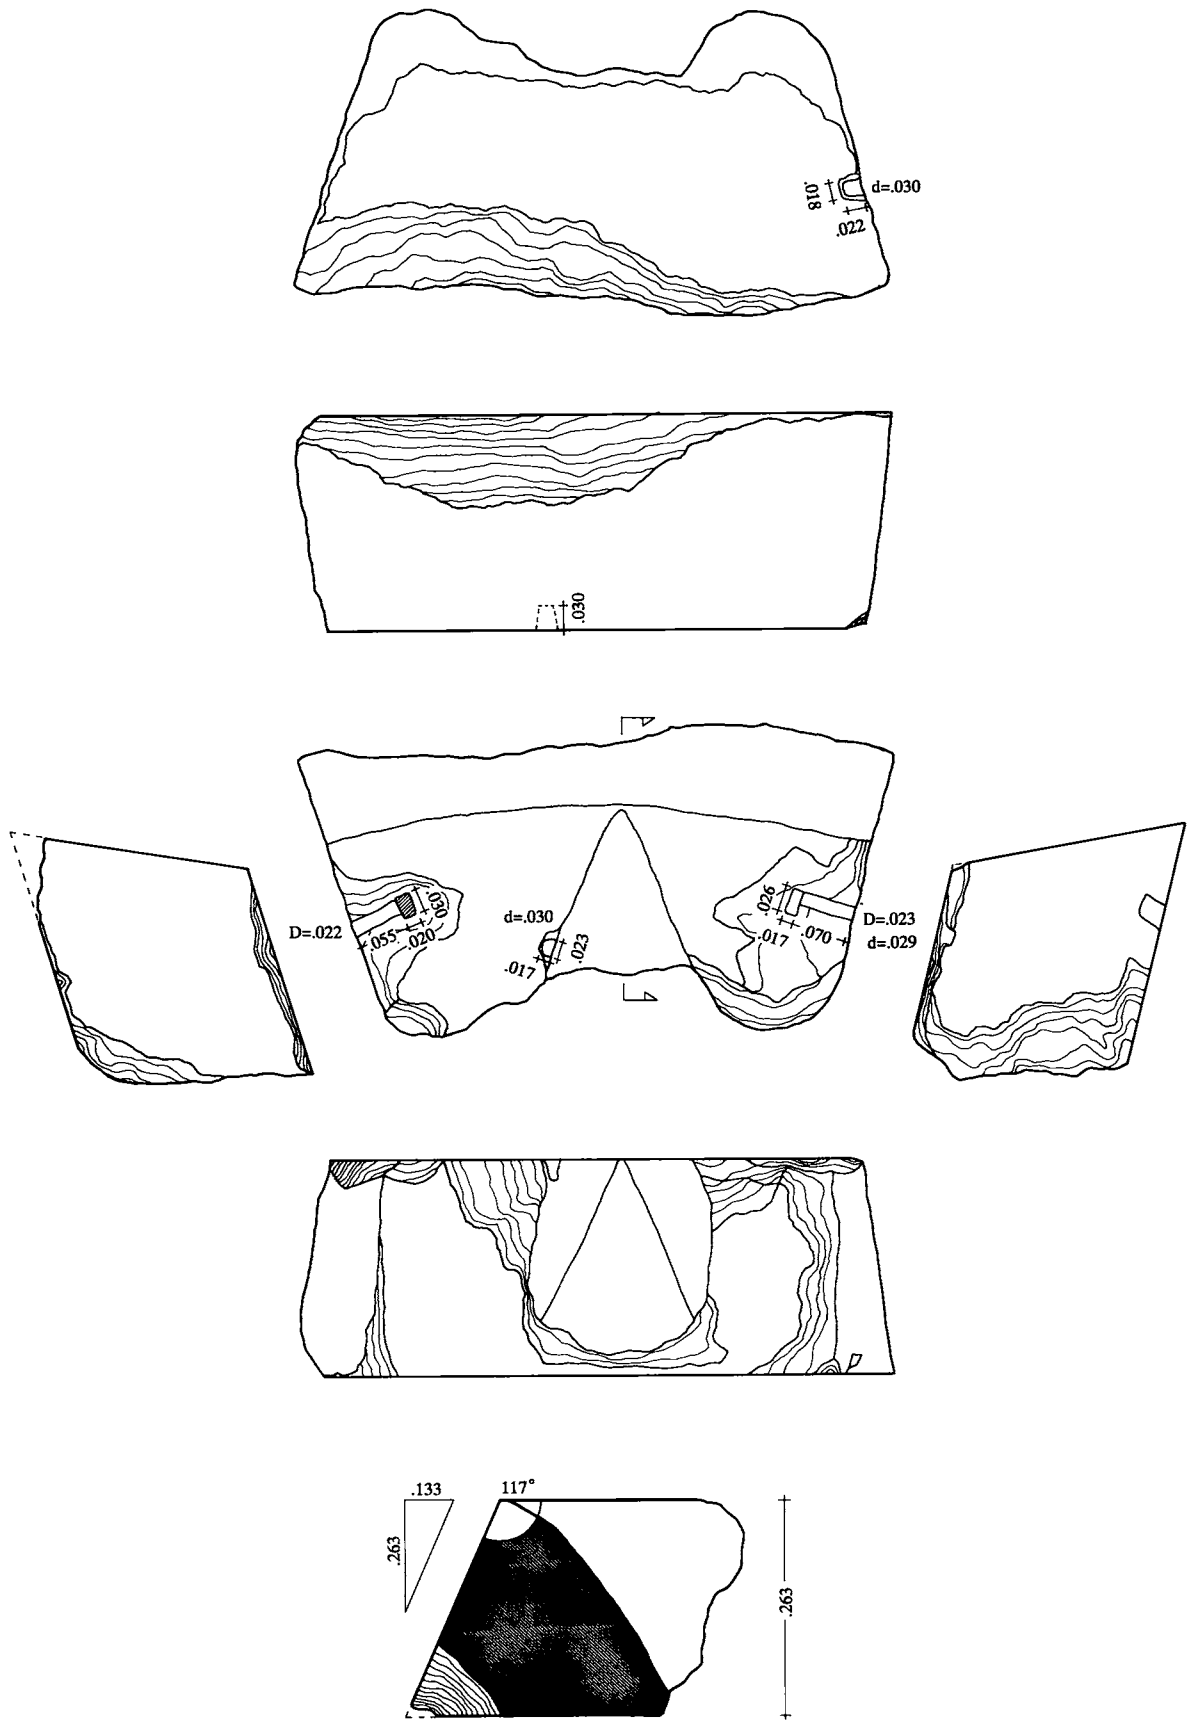
Fig. 37 K3, Roof block with a triangular cut, XI.117
