**ARCHITECTURAL STUDIES OF THE THREE GRAVE MONUMENTS
IN THE GYMNASIUM COMPLEX AT ANCIENT MESSENE**

Preliminary Report

Juko Ito

**Architectural Mission to Greece
Kumamoto University, Japan**

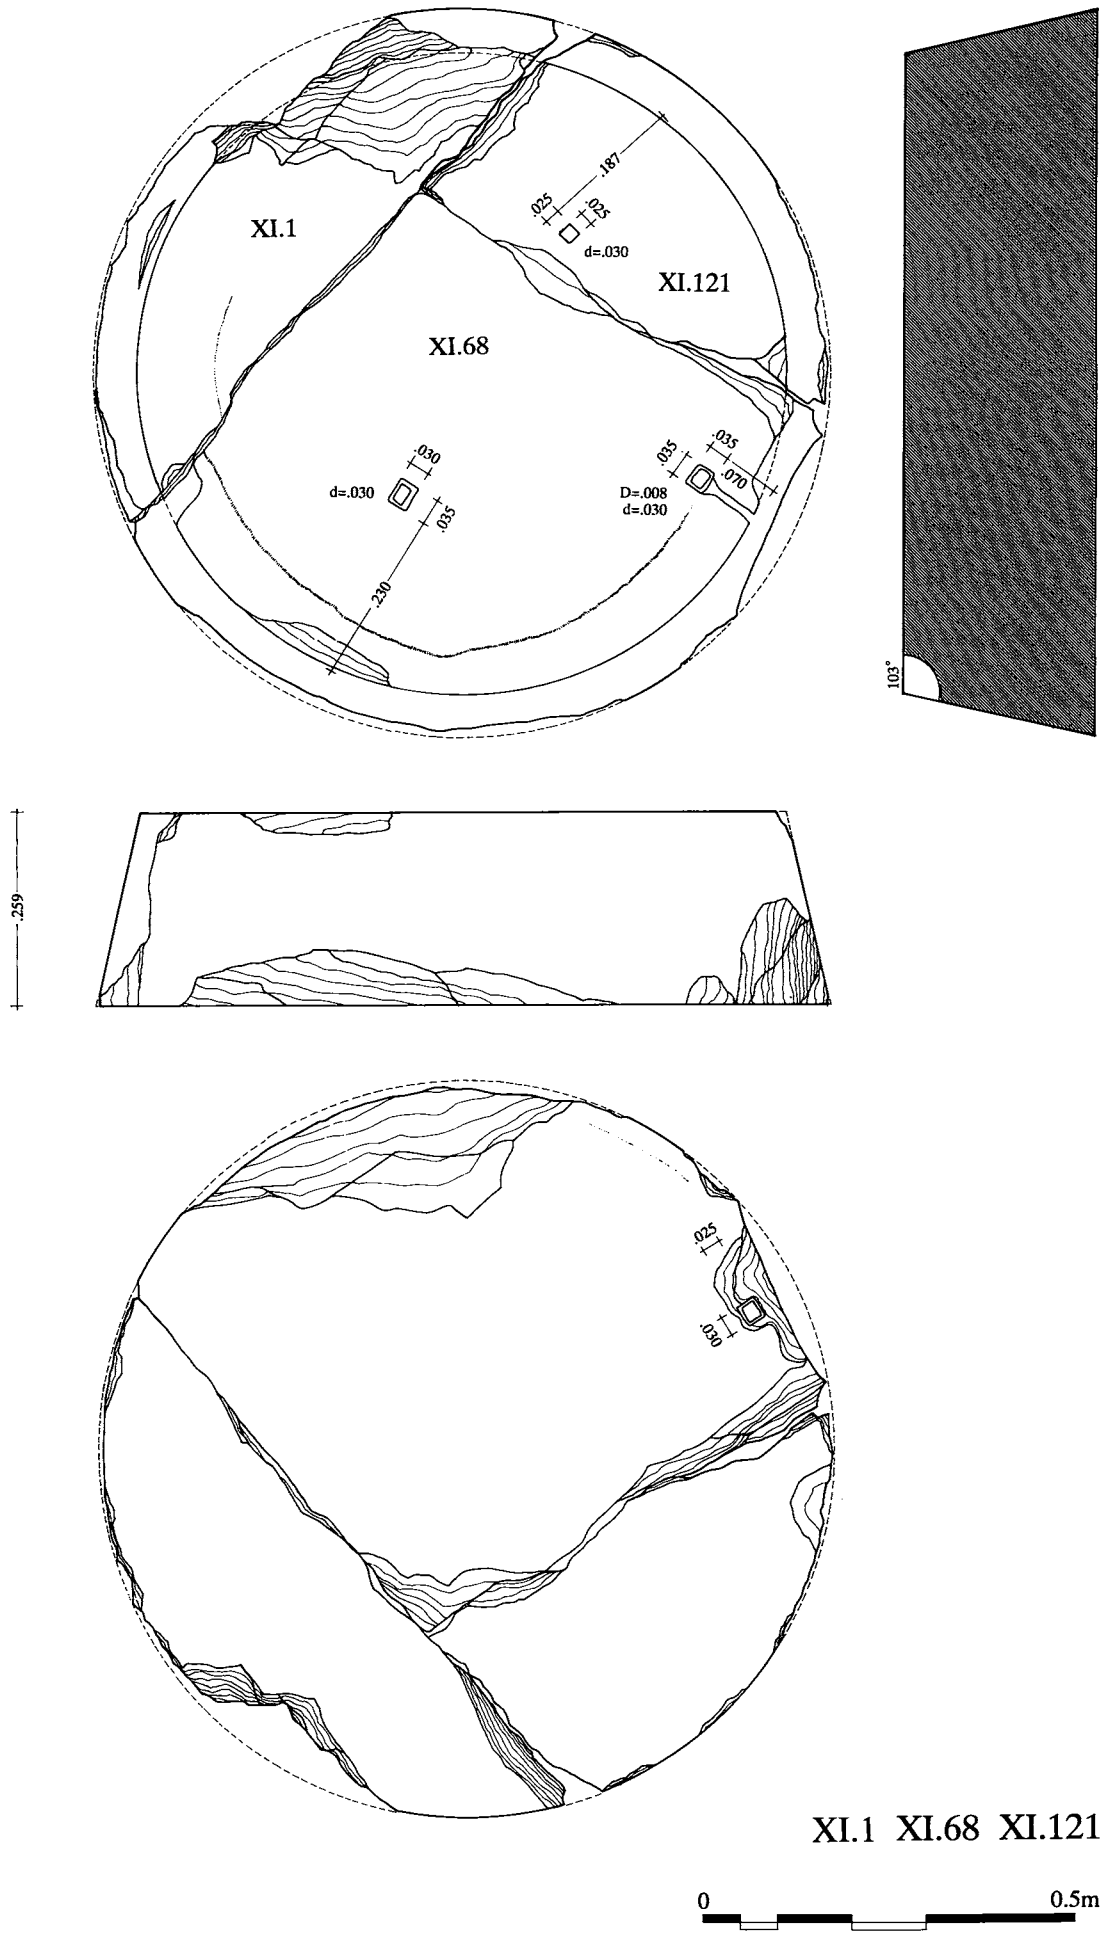
Fig. 38 K3, Truncated roof block, XI.1, XI.68, XI.121

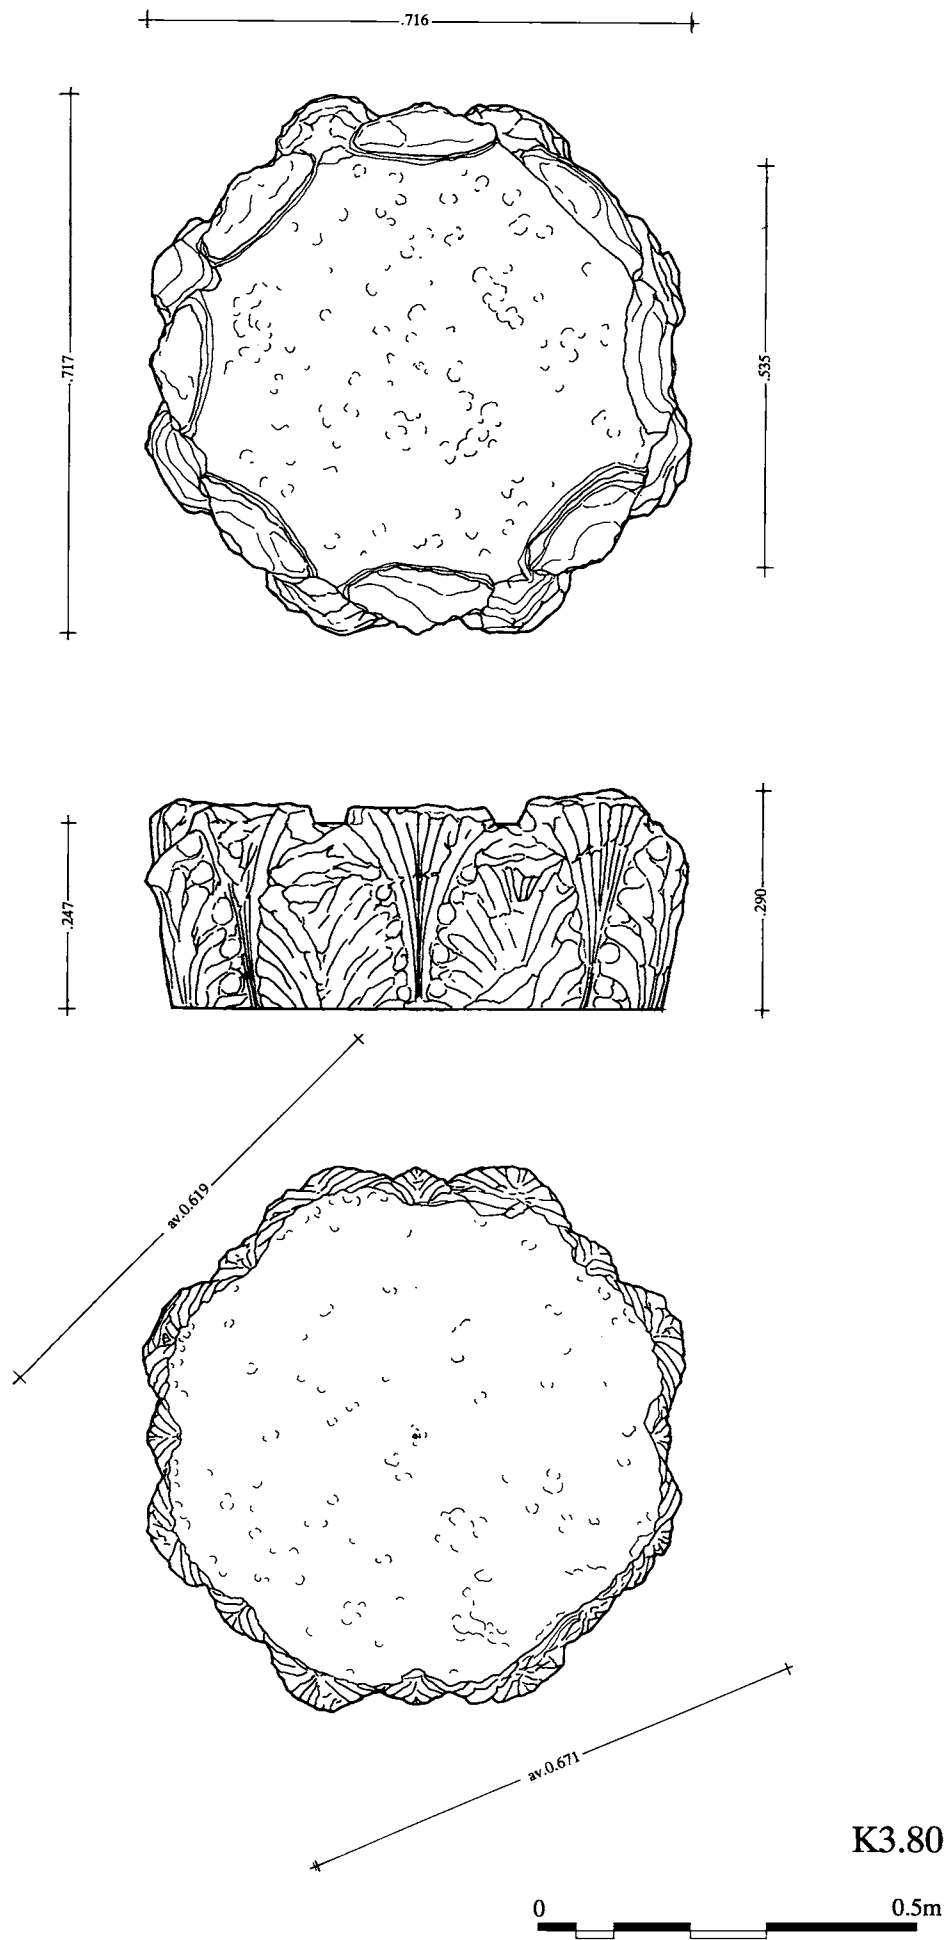
Fig. 40 K3, Lower half of the finial of the Corinthian capital, K3.80

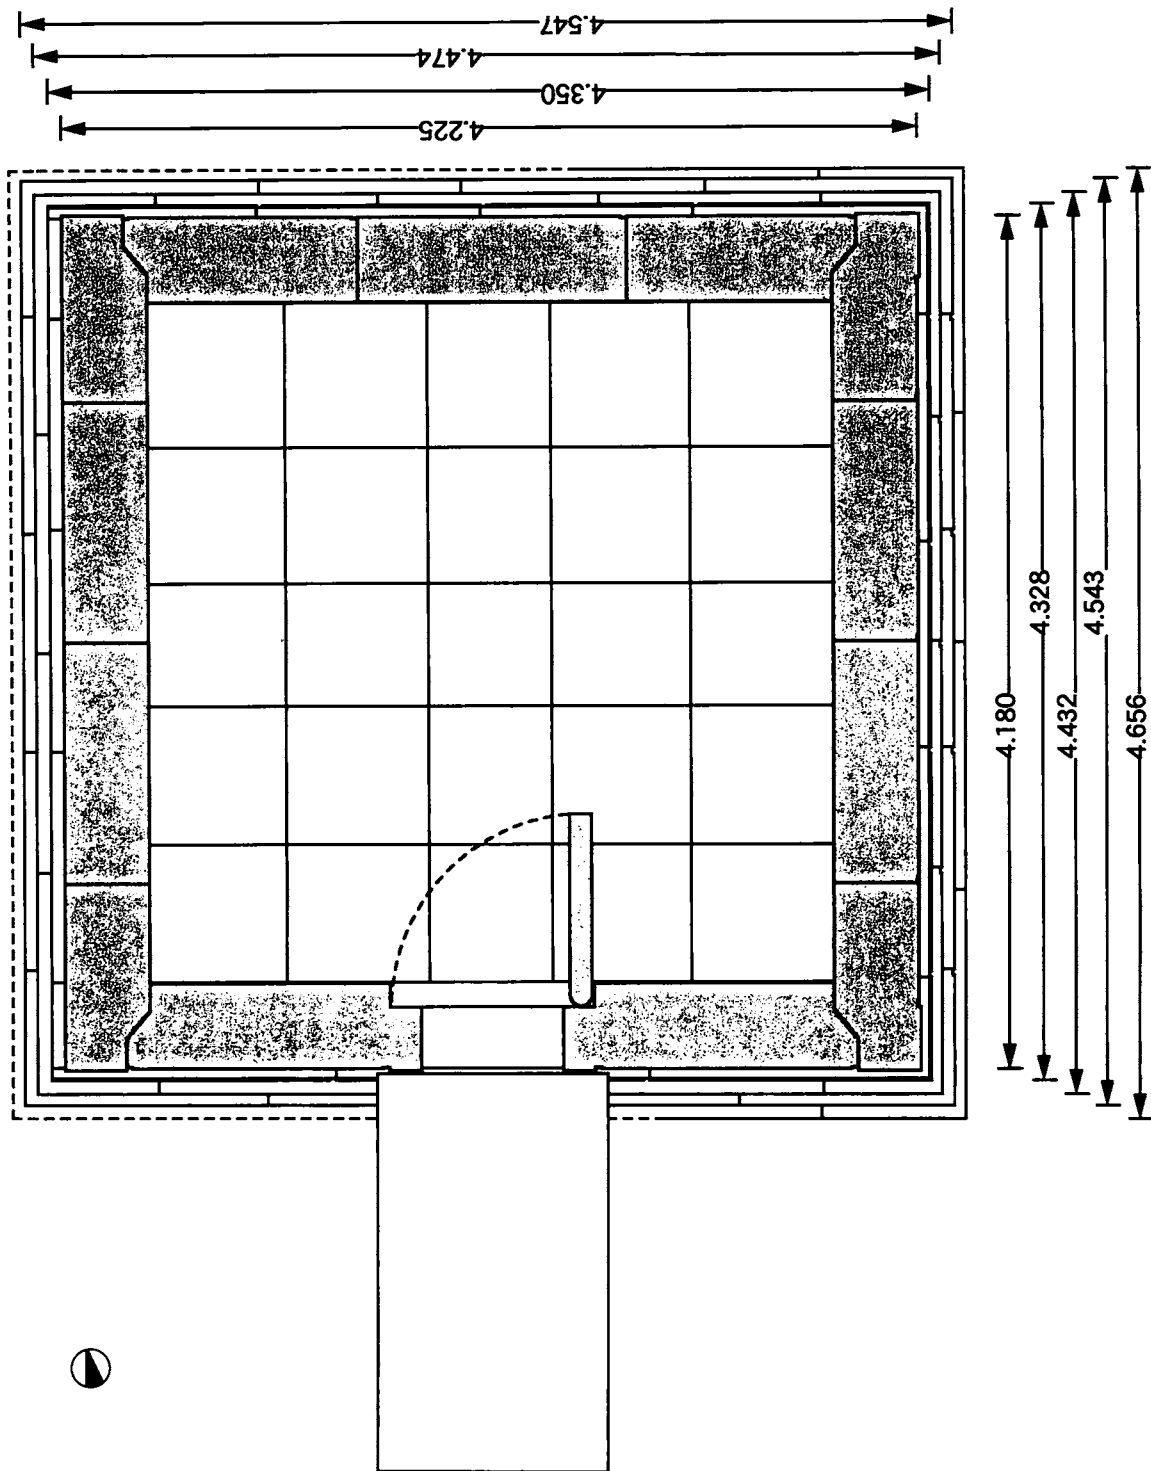
Fig. 43 K3, Plan reconstructed

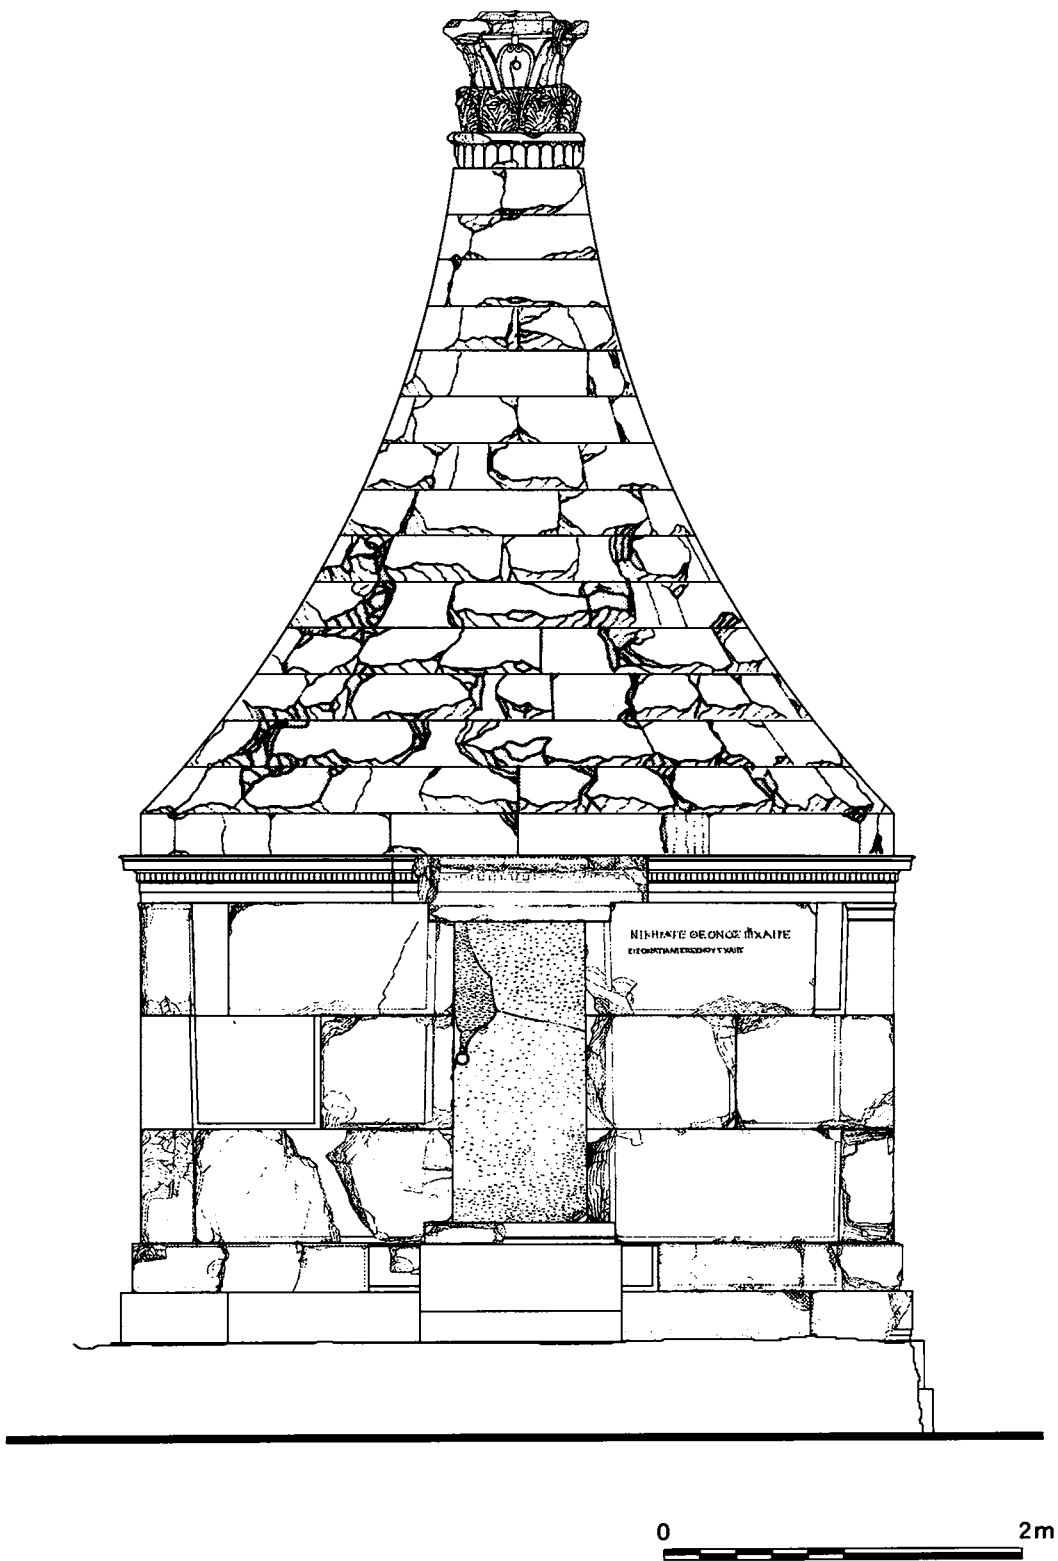
Fig. 44 K3, South elevation reconstructed with original blocks

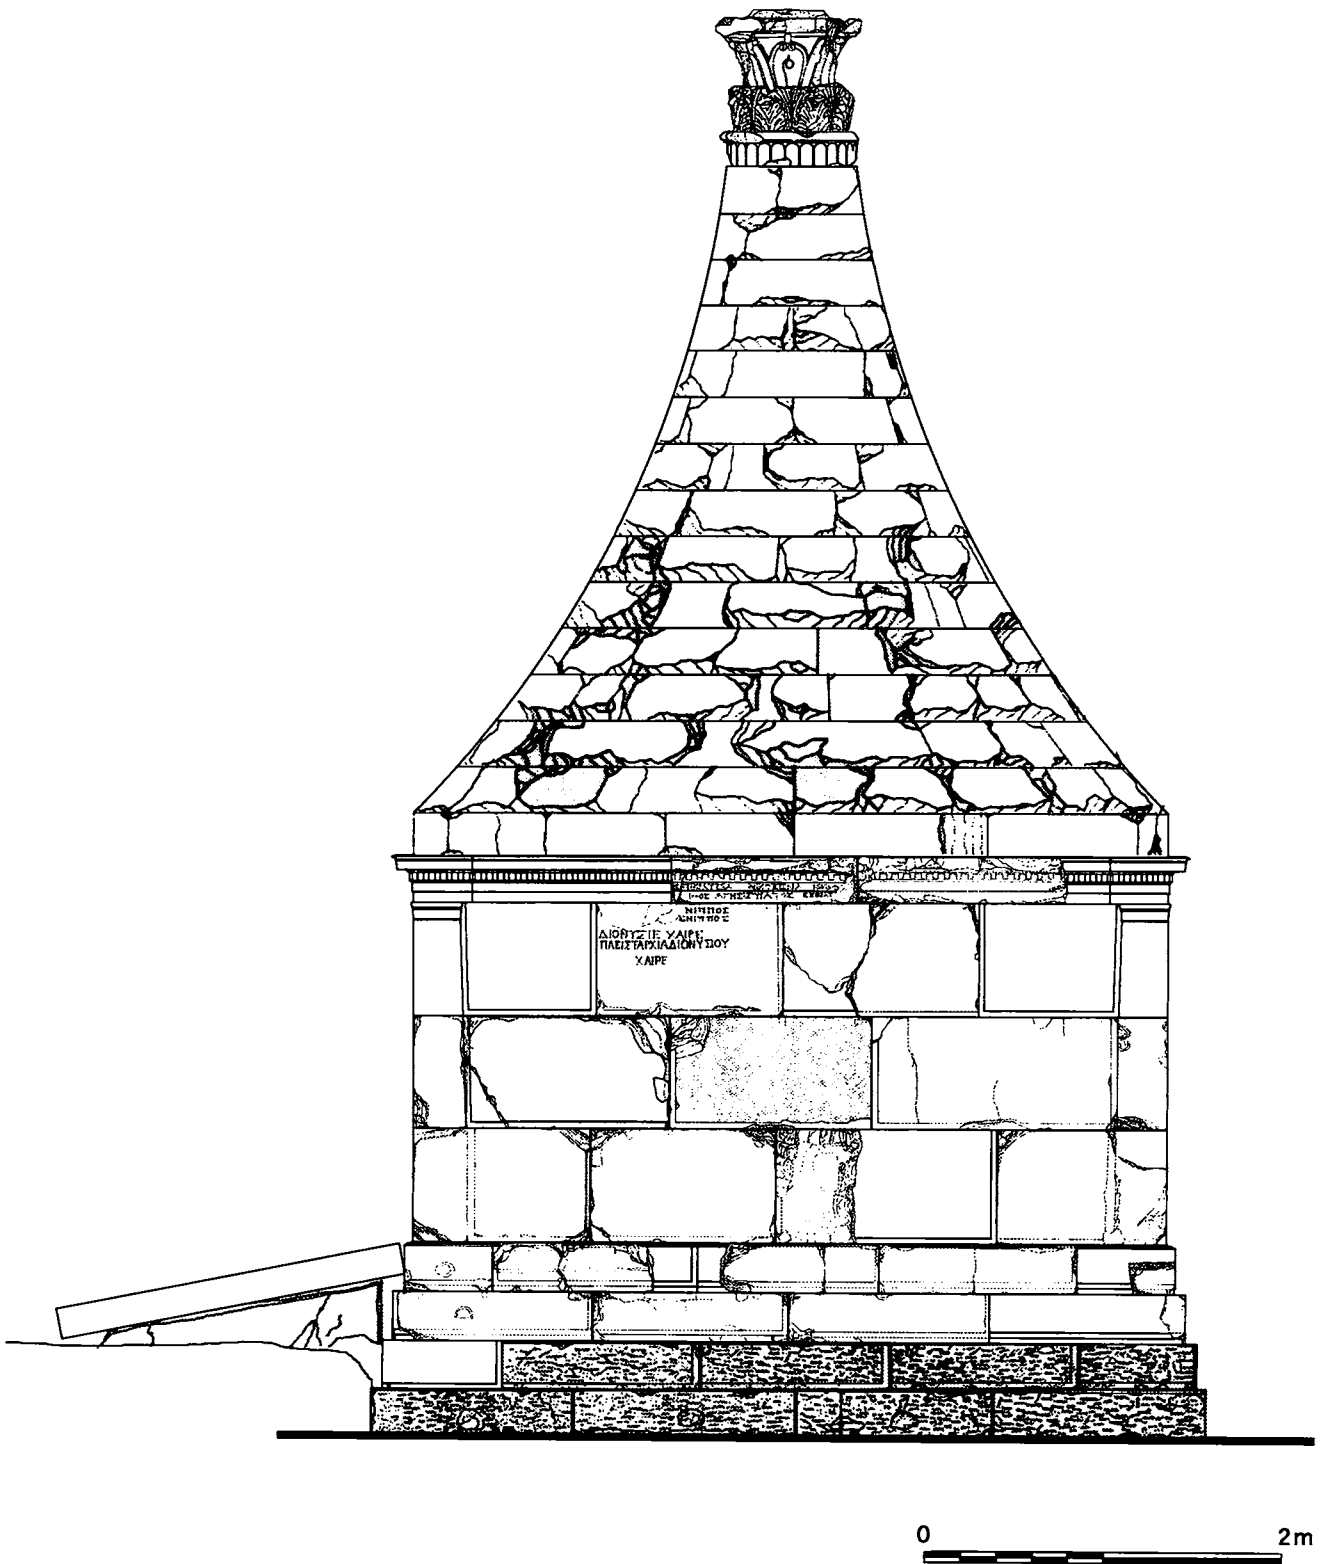
Fig. 45 K3, East elevation reconstructed with original blocks

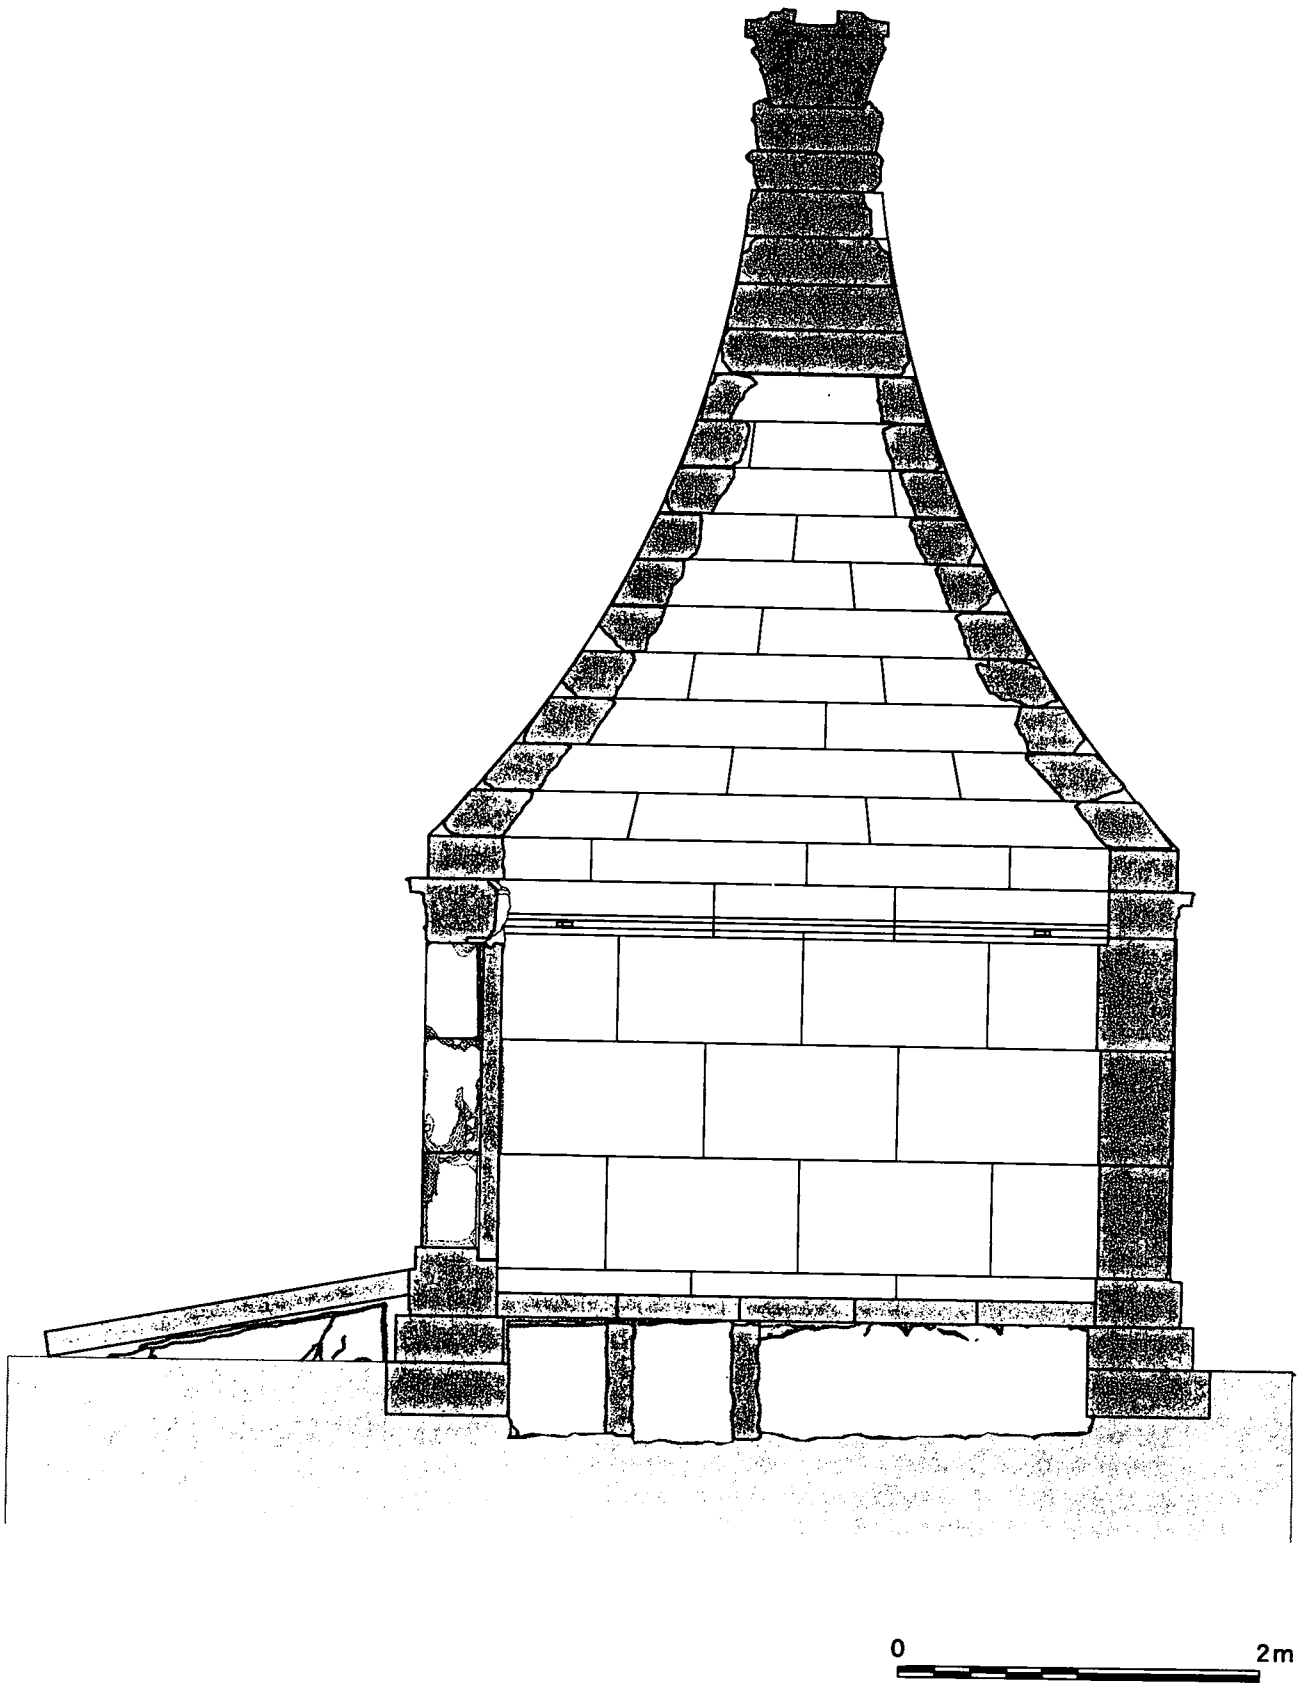
Fig. 46 K3, N-S section reconstructed

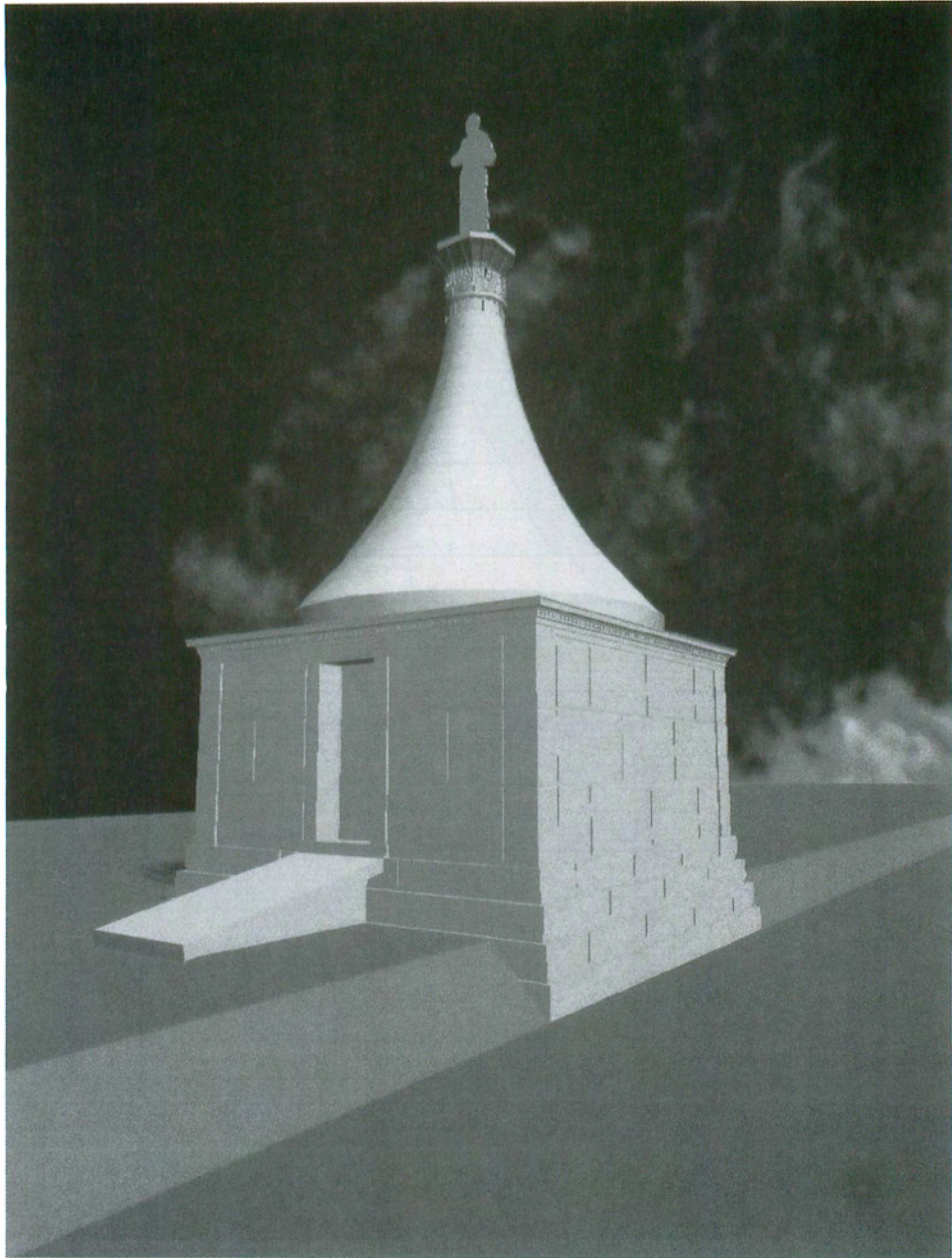
Fig. 47 K3, View reconstructed in 3D computer graphics

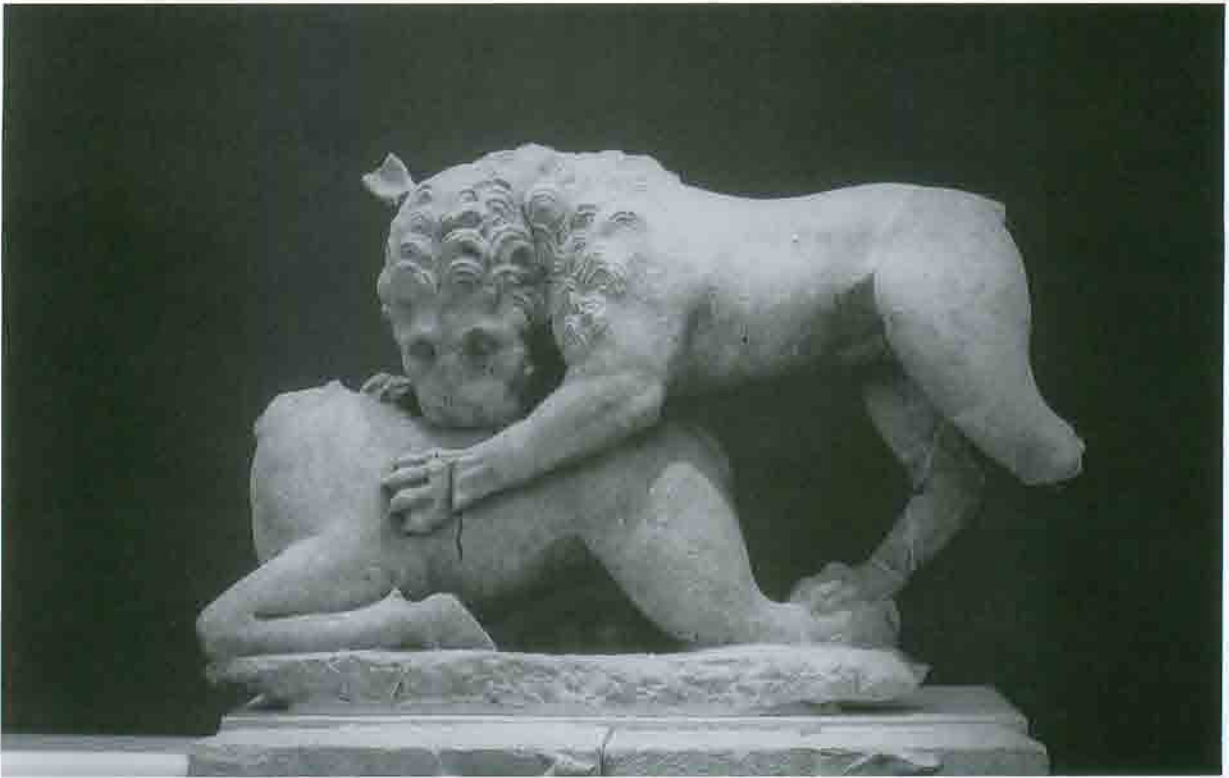
Pl. 9 K1, Statue of a lion attacking a deer (7416 group)

The 7416 group comprises pieces of a sculpture of a lion attacking a deer which is carved in limestone in the round on a single base. (Fig. 11, Pl. 9)⁴⁾ First, let us describe the deer, which is falling on its knees. Its left forelimb is deeply folded back at the knee, and its end is indicated by a pair of nails, a ring of hair and a hoof which is cut in the middle. The separation between the body and the left forelimb is simply formed by a fine incision. On the other hand, the right forelimb is broken off from the upper part of the joint and lost. Judging from the angle of the break of the limb, it is supposed that it was most likely raised in front of the thorax.

The right rear limb folds in two, and its hoof ends can be viewed from the front. The left rear limb is stretched backward and both the end of the limb and the back of the base are broken. Thus the hoof, ring of hair and nails are lost. It is remarkable the remaining upper part of the limb is still held in the right rear limb of the lion.

The neck and head are broken off at the base of the neck. The left ear is still attached to the lion's mane, however, though it is broken in the middle. The fact doubtless indicates that the deer's head was turned to the left together with the neck.

The lion is firmly seizing its prey in both forepaws. The claws of the right forepaw are fastened in the back of the deer and the left claws in its side. Its right rear limb is holding down the left rear limb of the deer. The left rear limb of the lion is free and hangs in midair, but it is broken at the joint. The tail is completely broken off from the body. The lion's head is turned toward the left, and its eyes are fixed in front with an expressionless face as it bites the back of the deer. (Pl. 10) Atop its head, a mane is carved in semicircles which are symmetrically arranged in order, eight on each side. Both ears are carved as holes in the semicircles. The semicircles become wavy at the shoulder, and cover the neck.

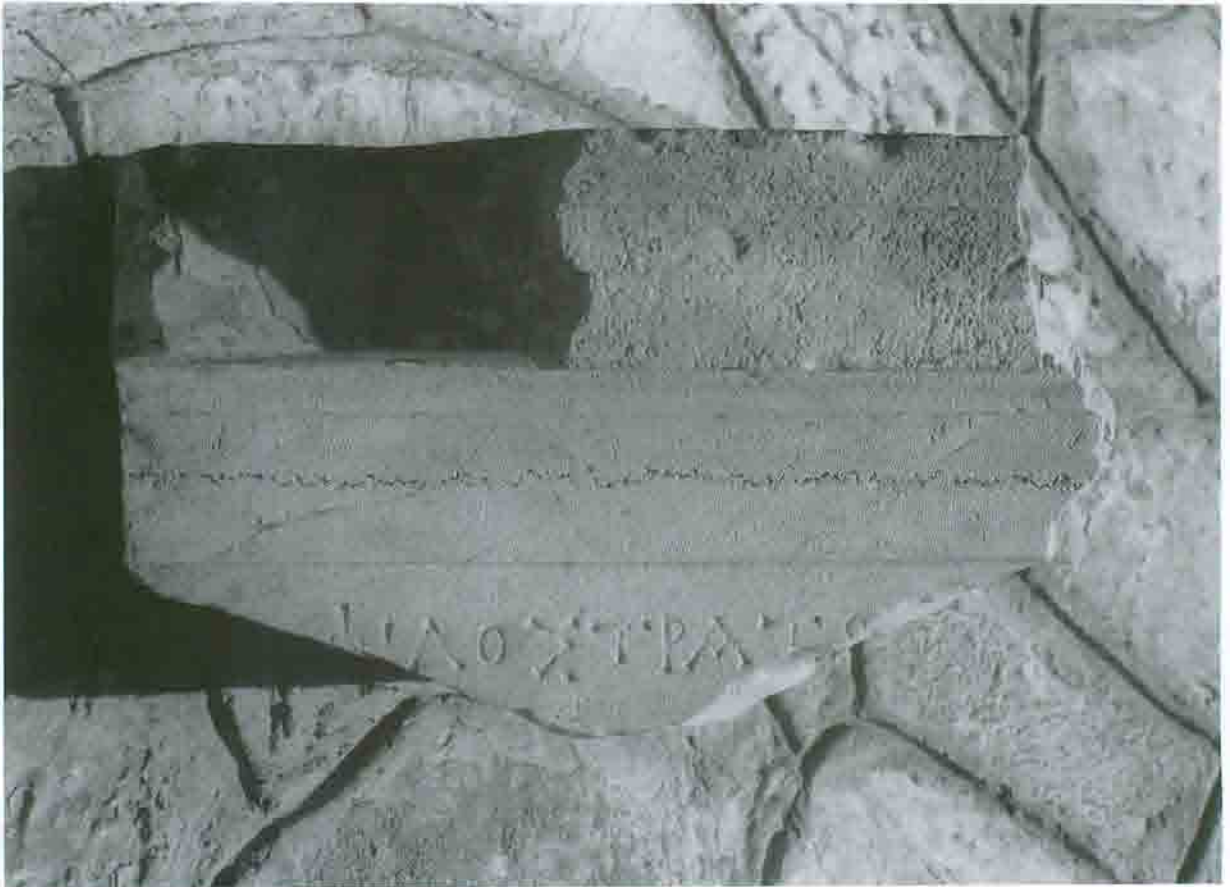
Pl. 25 K2, Cornice block with an inscription

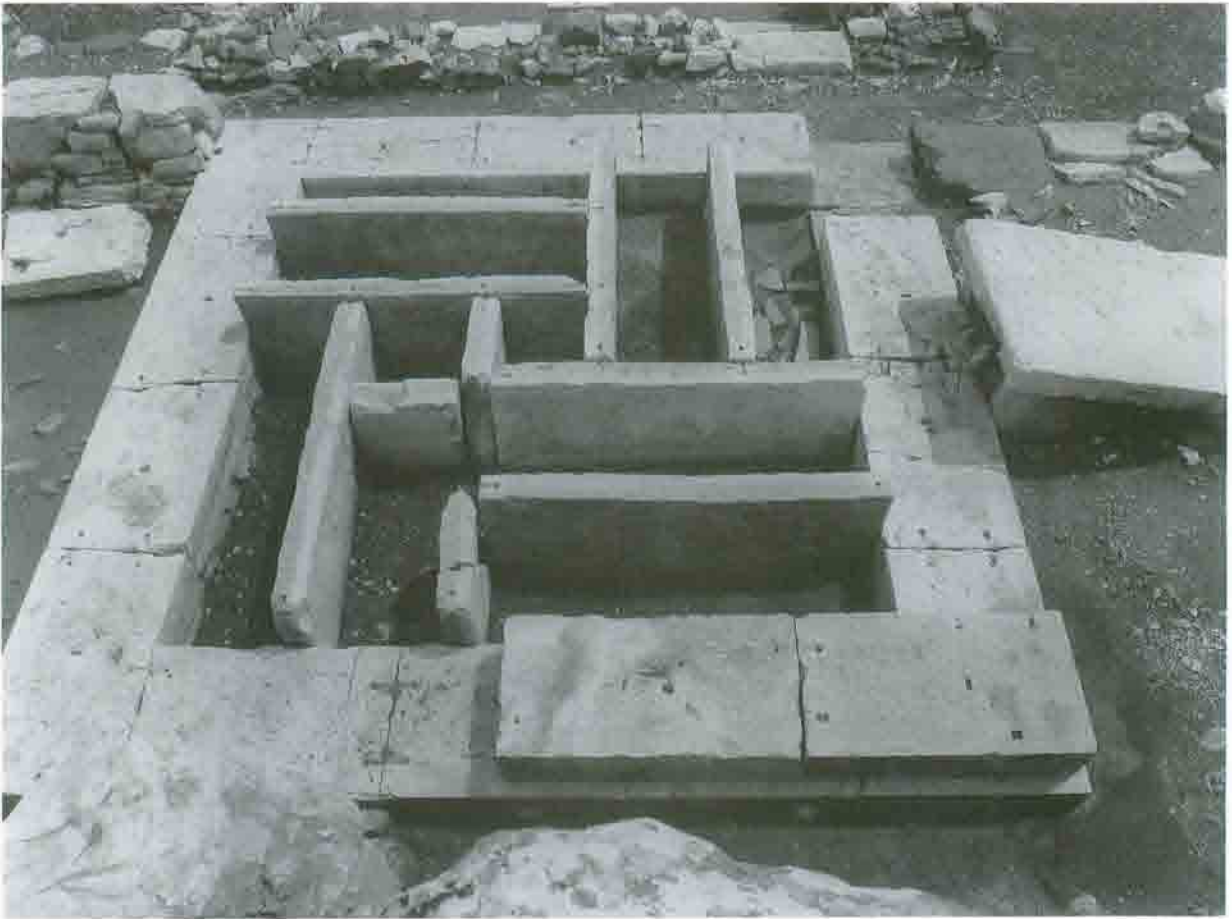
Pl. 28 K3, Tombs separated by cists

The lower crepis consists of 14 blocks, one of which on the southeast corner is missing. (Pl. 28)

Inside K3 is a tomb chamber with eight cists or tombs for corpses under the floor. (Fig. 24, Pl. 28) The dimensions of the interior at the lower crepis level are: 3.200 m on the east, 3.228 m on the north, 3.213 m on the south. The cists are separated by rough slabs ca. 1.82 m long, ca 0.15 m wide and 0.64 m high. The distance between the slabs is uniformly ca. 0.56 m from surface to surface. Four pairs of cists, located side by side in parallel, are arranged in spiral form. This arrangement leaves a pit of 0.42 m square in the center. The slabs were joined by clamps which are now missing. The separating slabs incline eastward by the pressure of the mud slope of the site. Due to this inclination, the difference of the levels from

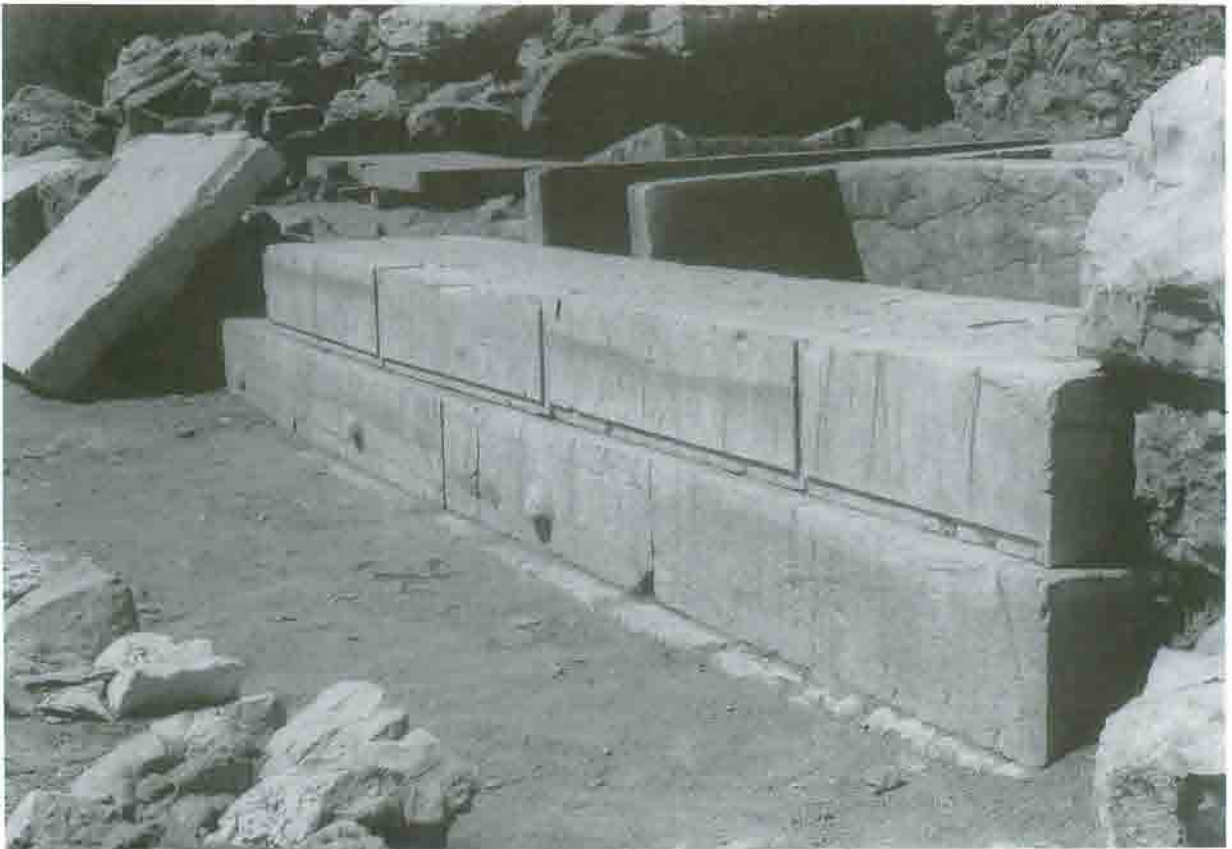
Pl. 29 K3, Front crepis

The lowest course is the euthynteria, laid on a foundation of smaller stones. The foundation is exposed on the east side, but the rest has not been excavated and is covered by mud. (Fig. 24, Pl. 29) The lengths of the blocks on the east vary from 1.09 m to 1.25 m, the width is around 0.70 m, and the height 0.274 m. The total length of the east euthynteria is 4.656 m. On the four blocks of the east euthynteria remain handling bosses. On the upper surface of the block on the southeast corner, which is exposed due to the lack of the crepis block above, is a dowel hole set 0.053 m off from the west edge of the block. Clamps can not be recognized on the euthynteria, as far as we see from its southeast corner.

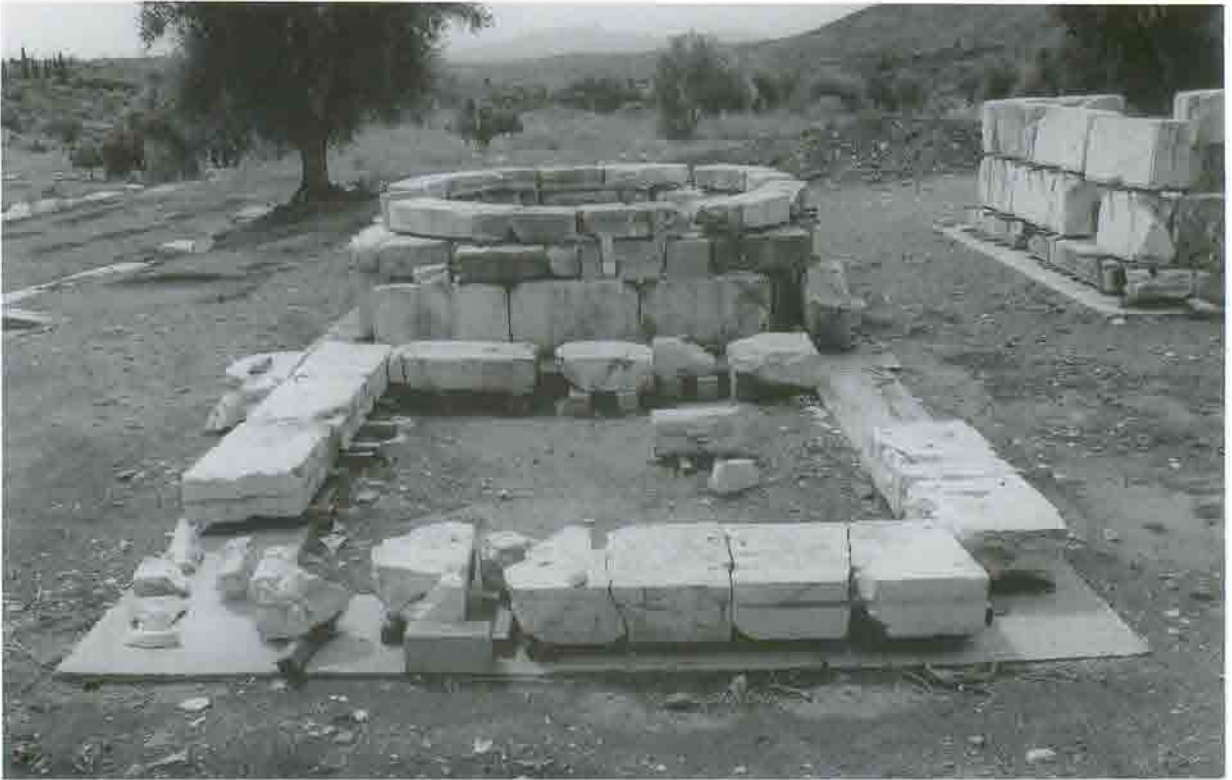
Pl. 46 K3, Upper crepis reconstructed
