ON-SITE MEASUREMENT OF DELAMINATION AND SURFACE CRACK IN CONCRETE STRUCTURE BY VISUALIZED NDT

ABSTRACT:

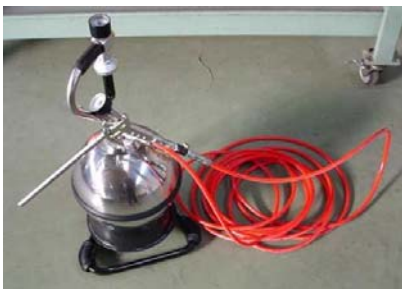
Fig. 1 Aluminum bullet for a projectile.

An aluminum bullet of 8 mm diameter and 17 mm length in Fig. 1 is shot at the impact point by a projectile system via compressed air (0.05 MPa) shown in Fig. 2. The projectile system consists of a portable compressor and a shooting device for the aluminum bullet. Elastic waves generated are detected at the surface by an accelerometer next to the impact point. It is confirmed that the system could generate the impact of frequency range up to around 50 kHz [3].

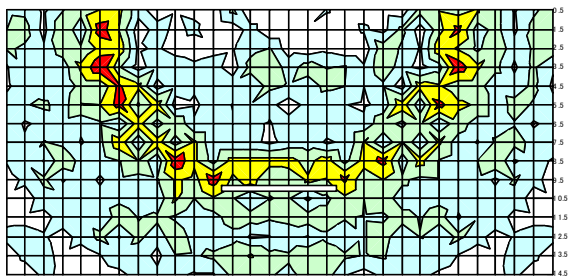
Fig. 11 SIBIE result at the point of No. 1.

A result at the point of No. 1 is shown in Fig. 11. The dimension of a mesh is 10 mm x 10 mm. The reflection intensity at each mesh is graded with 5 colors from high to low. The ordinate in the figures here-in-after denotes the depth of the cross-section with centi-meter unit. Because the delamination should exist at 100 mm depth, open rectangular area is inserted at 100

mm depth. The reflection intensity is classified by colors as indicate at the top. From the figure, it is realized that the delamination is really present, and the width of void gap could be around 30 mm. It is interesting that the effects of reinforcement at 50 mm depth and post-tensioning sheath at 85 mm depth are minor in the result. This is because the upper-bound frequency is set at 40 kHz, and thus the effect of shallow reflector becomes less dominant than the void.

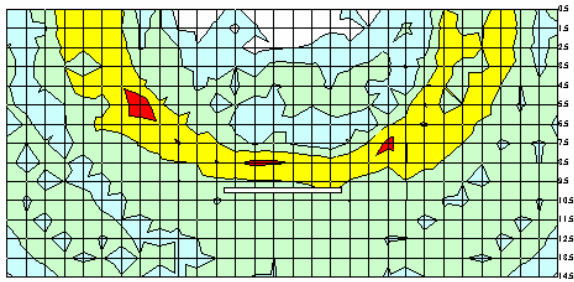
Fig. 12 SIBIE result at the point of No. 2.

A result at the point of No. 2 is shown in Fig. 12. Since the measurement point was located around a transition zone between delaminated and well bonded areas, the reflection intensity at 100 mm depth is fairly weak. But, it is still possible to identify the depth of delamination.

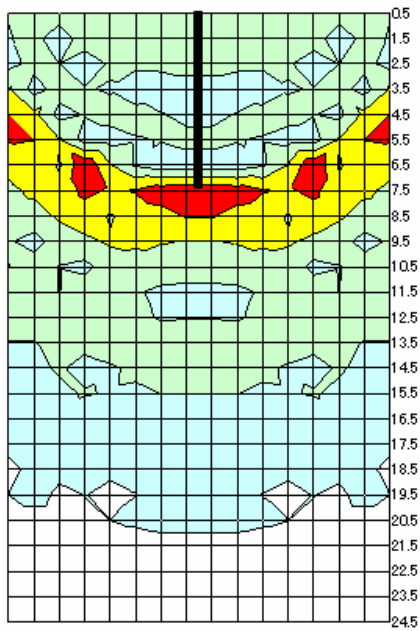
Fig. 13 SIBIE result at the point of No. 11.

A result at the point of No. 11 is given in Fig. 13. Weak reflection intensity is observed at an area upward apart from the assigned depth of the delamination (rectangular blank area). Because the thickness of PC panel is 100 mm, a shallower delamination than 100 mm is not plausible. This might be because the velocity of P wave was estimated as slower than actual. As realized in Table 1, P-wave velocity measured for Nos. 11 to 14 is the slowest of all. It is known that the velocity measured in the surface method could be slower than that of the through-transmission method. The area of Nos. 11 to 14 is a curved end of the pier, and thus the slower velocity might result in estimation of a shallower delamination in the analysis. It is noted that the reflection intensity is not so high in comparison with other cases. Therefore, it might suggest that the portion is not evidently delaminated.

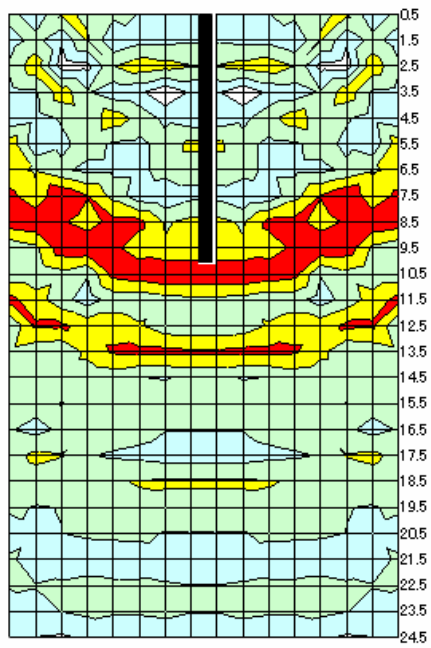
Fig. 15 SIBIE result at the point of No. 10 (0.2 mm width).

the point of No.10 in Fig. 15, the depth is estimated around 95 mm. This implies that a surface crack could be referred to be a through-thickness crack in the PC panel. Since the crack-mouth opening width was 0.2 mm, these two cases suggest that surface cracks with the width over 0.1 mm possibly extend up to around the bottom of the PC panels.

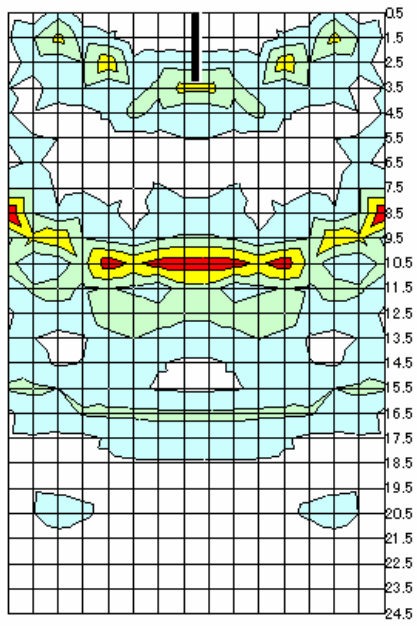
Fig. 16 SIBIE result at the point of No. 17 (0.1 mm width).

Another case of 0.1 mm crack width is given at the point of No. 17 in Fig. 16. Here, two zones of high reflection intensity are observed. One is located at around 100 mm depth. So, the crack line is drawn up to this depth, suggesting a through-thickness crack in PC panel. In the case, the crack width of surface opening was 0.1mm. The second is observed at around 130 mm depth. This implies that the void of delamination is present below the surface crack. The surface crack reaches to the depth of the PC panel, and the delaminated void of around 30-40 mm width might be created between the panel and the concrete pier.
