地學雜誌

2012 VOL. 121

九州北部豪雨によって斜面崩壊が多発した阿蘇カルデラ壁

July 2012 Rainfall-induced Landslides at the Eastern Wall of Aso Caldera

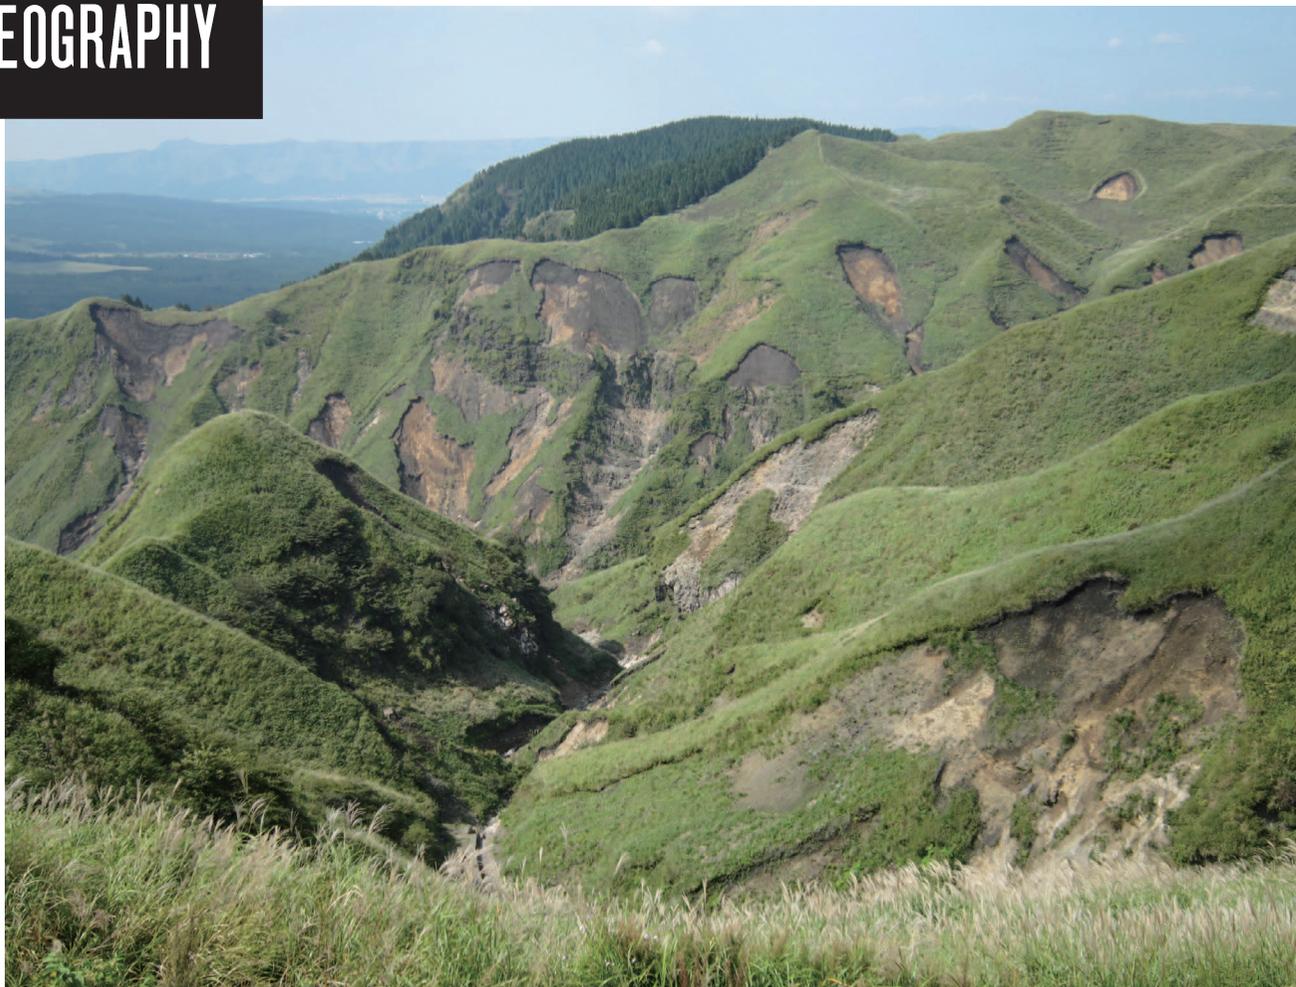
表紙写真

2012年7月11日から12日にかけての九州北部豪雨は、阿蘇カルデラとその周辺域に斜面崩壊や河川氾濫などの深刻な被害をもたらした。とくに降雨が集中した東側カルデラ壁の草地斜面では多数の斜面崩壊が発生した。斜面崩壊の大部分は岩盤が大きく崩落するものではなく、深さ数mの火山灰層が滑落する浅層崩壊であったが、崩壊土砂は細粒物質が多いため、ラハールとなって河川を流下した。この地域では1990年7月や2001年6月にも多数の斜面崩壊が発生しており、今回と共通した特徴をもっている。

Intense rainfall on 11-12 July 2012 triggered numerous landslides and associated lahars in Aso caldera, southwestern Japan. Several landslides were observed especially on grassy slopes of the eastern caldera wall. Most of the landslides were shallow soil slips (< 1-2 m thick) in unconsolidated fallout tephra layers overlying lava and welded Aso pyroclastic-flow deposits, and some landslides were mobilized completely into lahars, traveling a few kilometers along stream channels. Similar landslide and associated lahar disasters occurred at Aso Volcano in July 1990 and June 2001. The characteristics of landslides and lahars provide important information for preventing or mitigating future similar disasters in the Aso caldera region.
